ENGINEERING DEPT.  
**GREATER VANCOUVER  
SEWERAGE AND DRAINAGE DISTRICT**

**STUDY OF**

**COQUITLAM / PORT MOODY  
DRAINAGE AREA**

**DAYTON & KNIGHT LTD.**  
*Consulting Engineers*

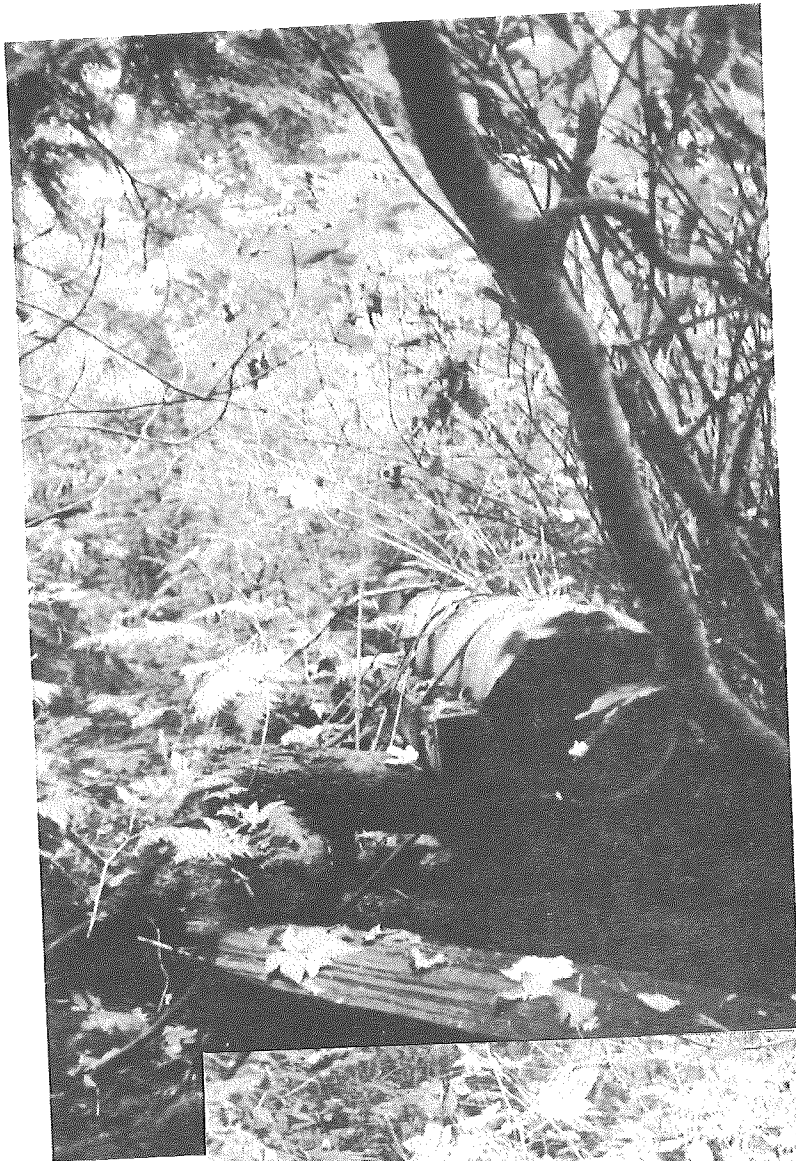
Reach S4.

Ingersol Avenue Outfall

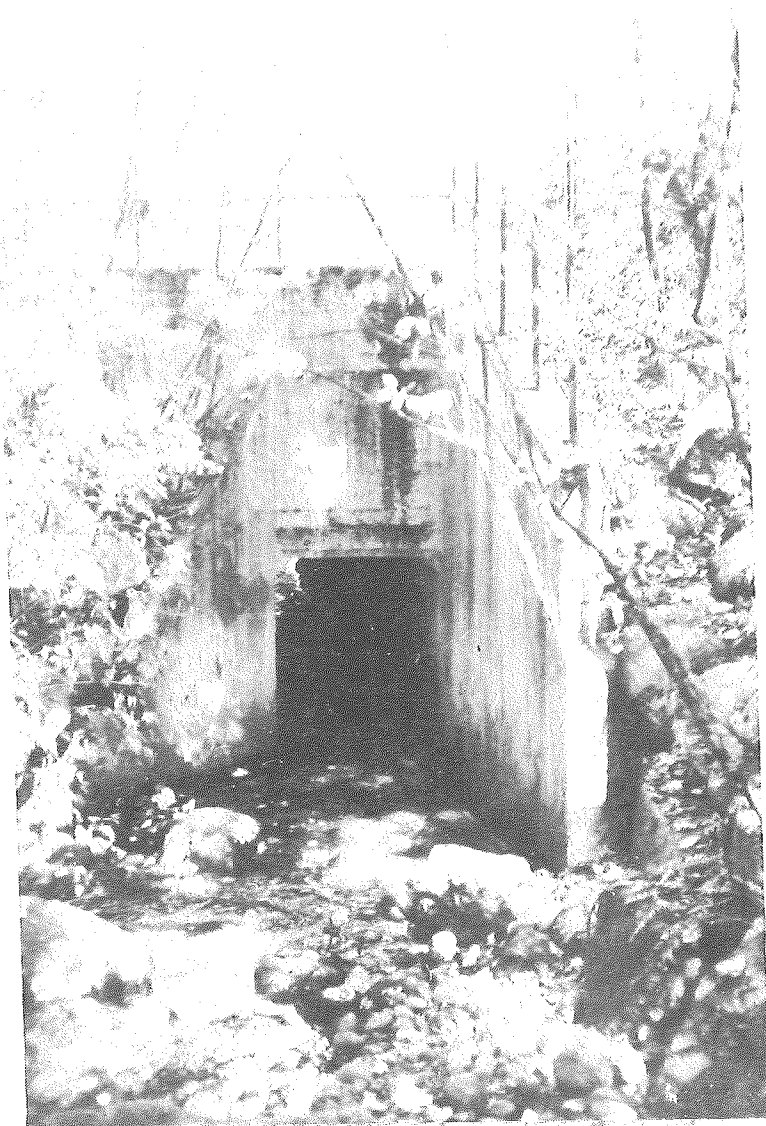
Reach S6

Schoolhouse Creek downstream of School Creek crossing Albert Creek at headwall.

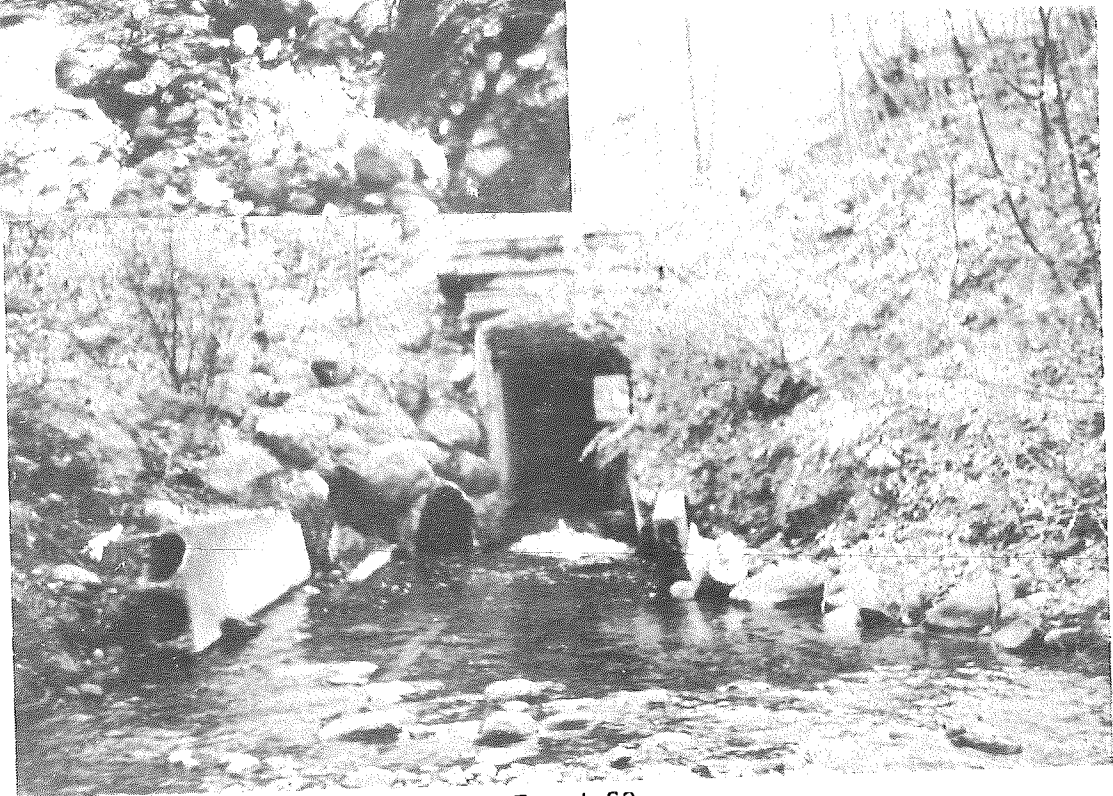
Reach S9

Looking upstream across Albert Street, shows Noble Creek discharge to Schoolhouse Creek at left.

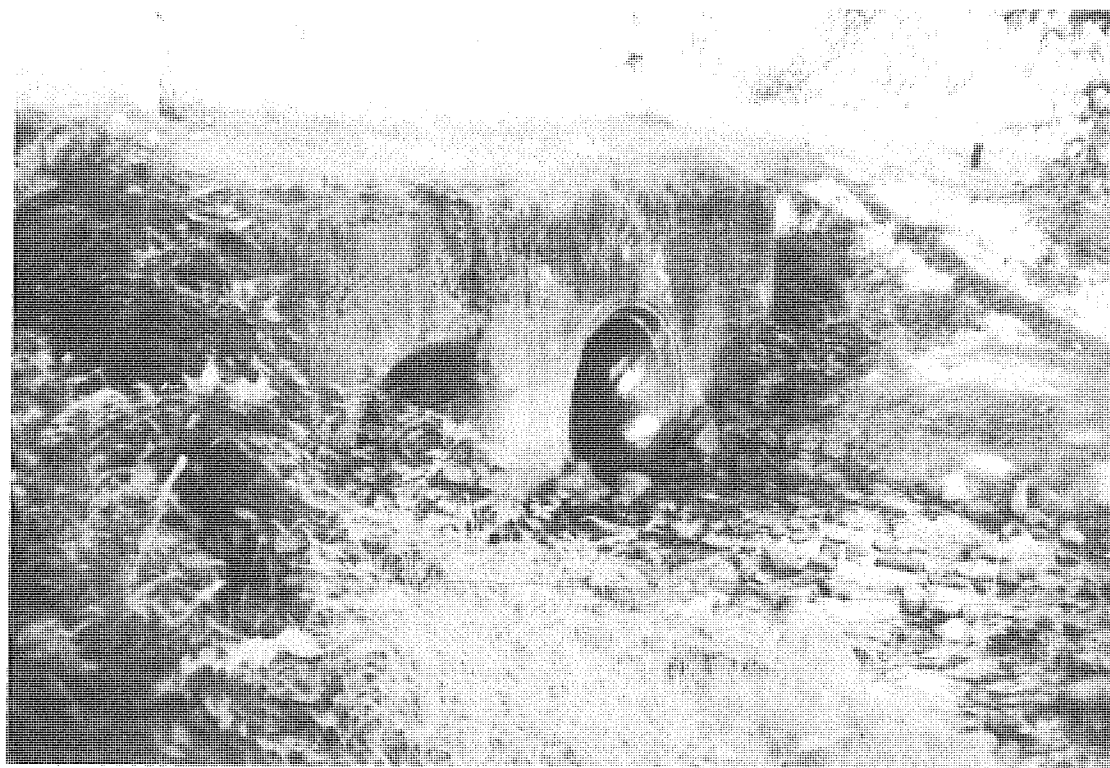
Reach S10  
Schoolhouse Creek crossing of St. Johns, looking downstream.  
September 9, 1987.

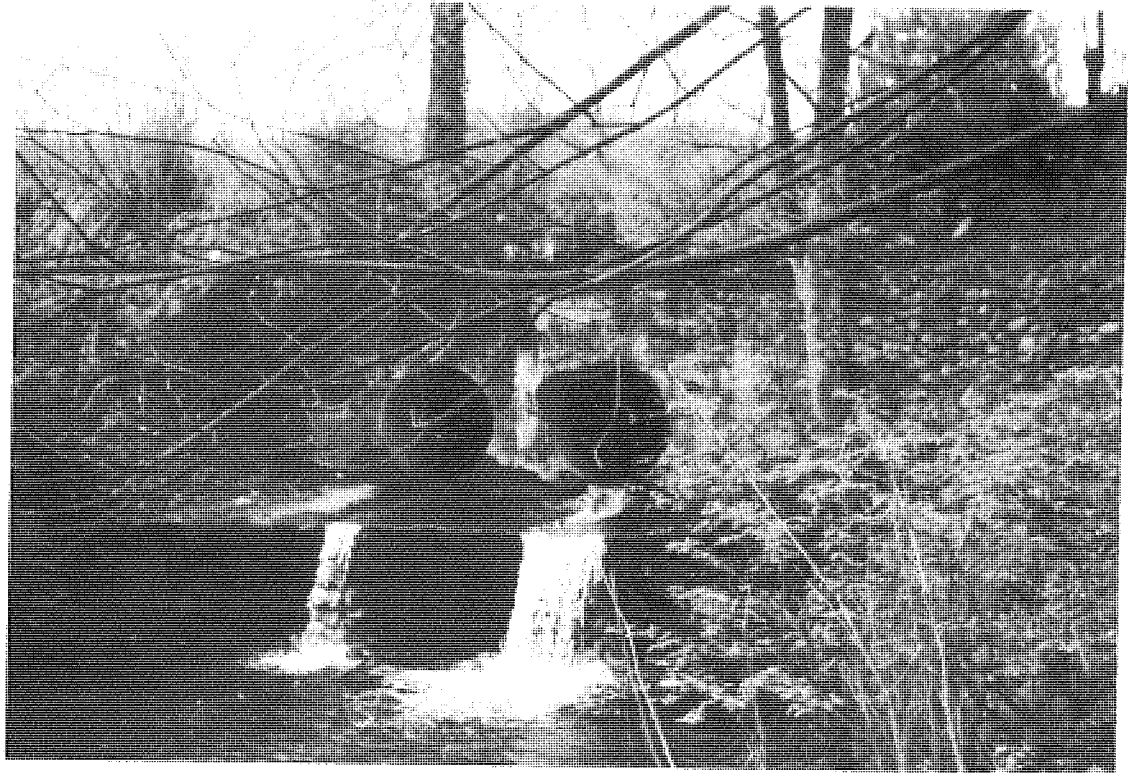
Reach S10/S11  
Drainage area outlet structure at St. Johns Street.

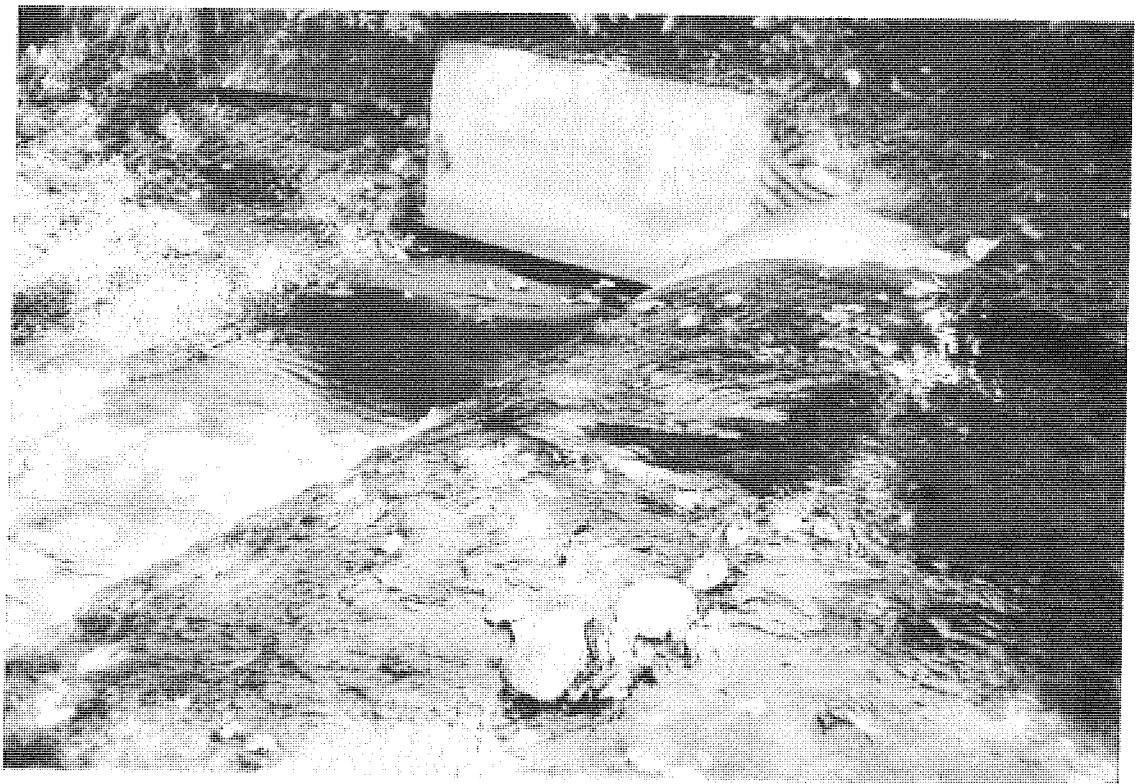
Reach S11  
Check dam downstream of St. Johns at pipe crossing.

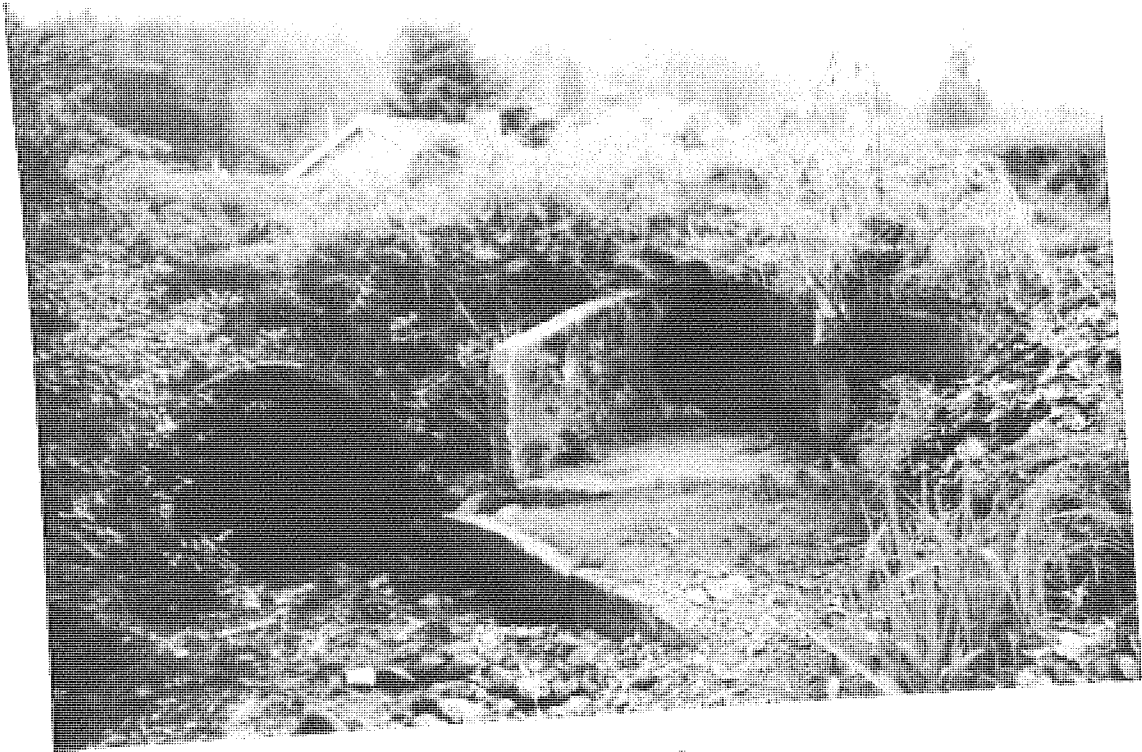
Reach S12  
Inlet structures at Clarke Street crossing  
1500 dia. woodstave pipe. 900 dia. concrete overflow.

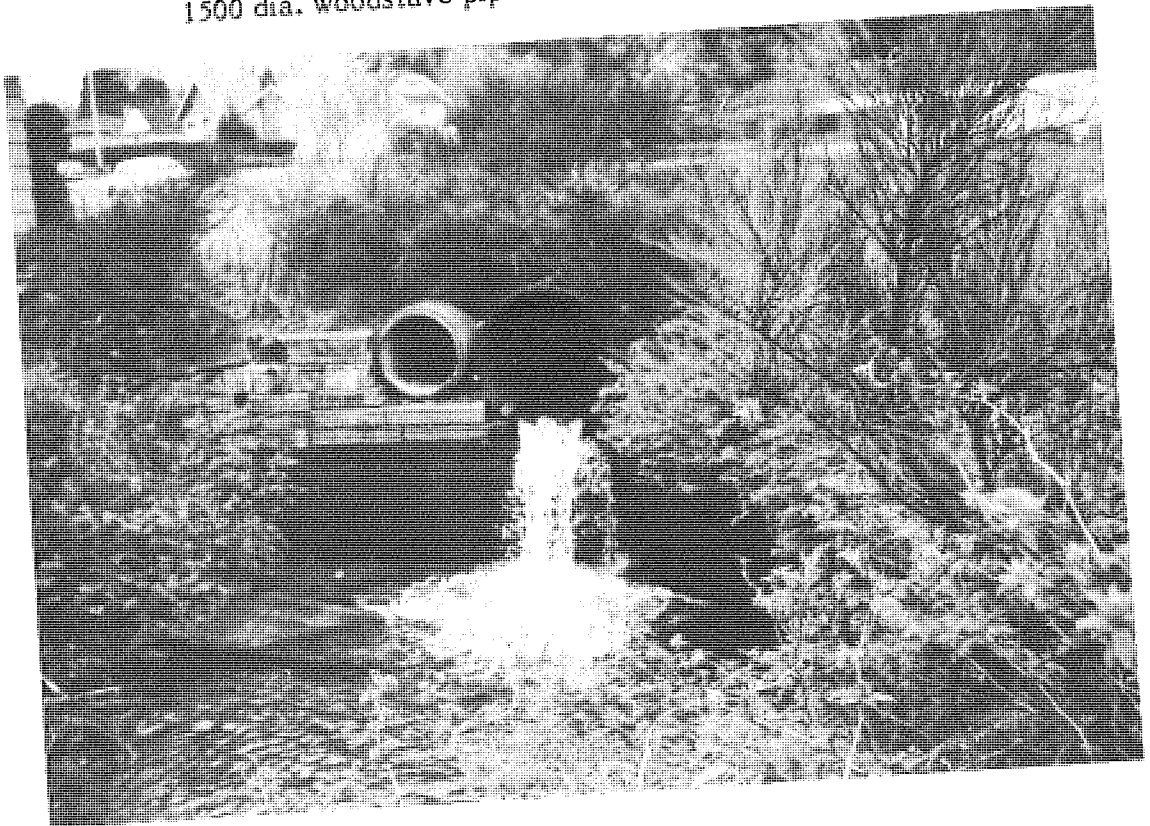
Reach S12  
Outlet structures at Clarke Street crossing.

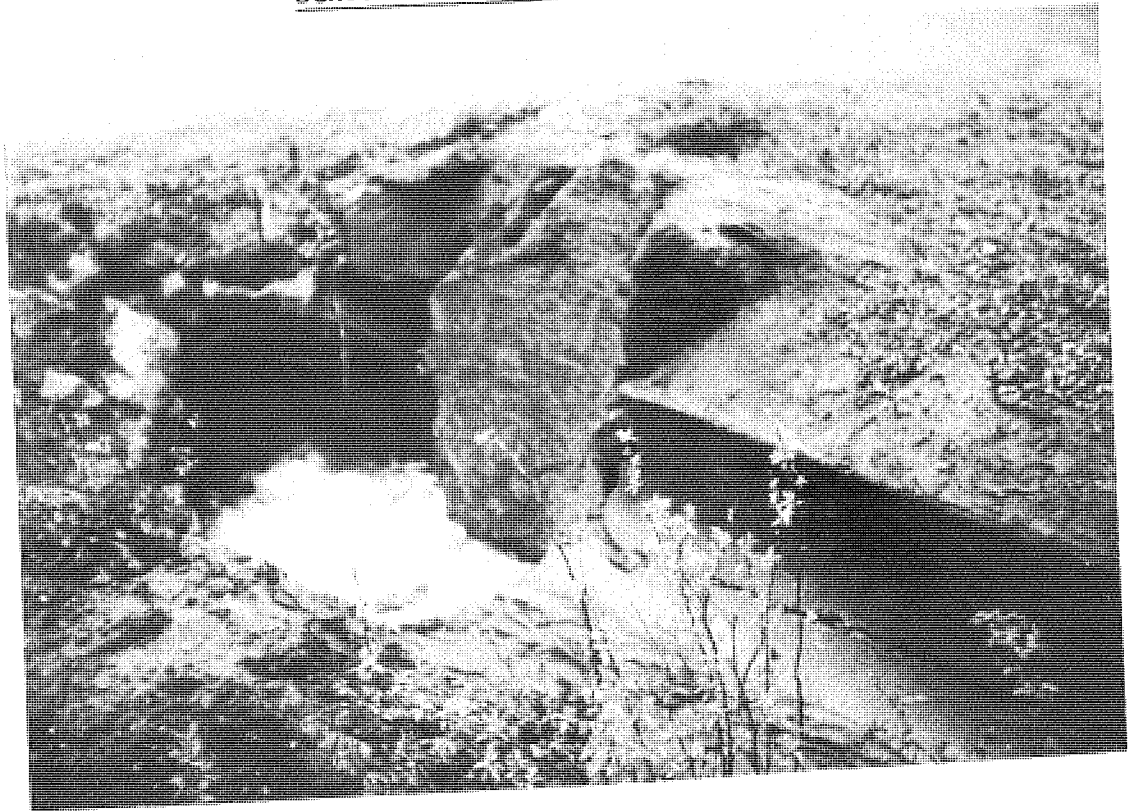
Reach S34/S35  
Major tributary 900φ

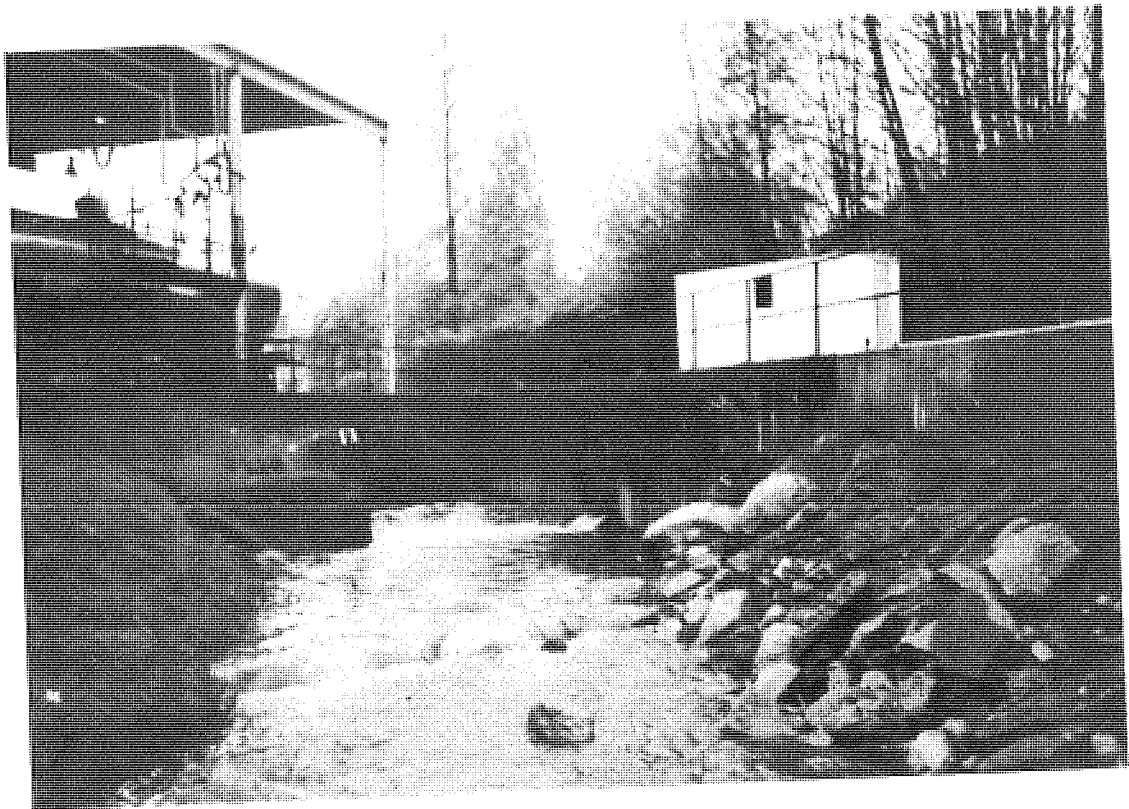
Reach S35  
Looking upstream to tributary confluence.

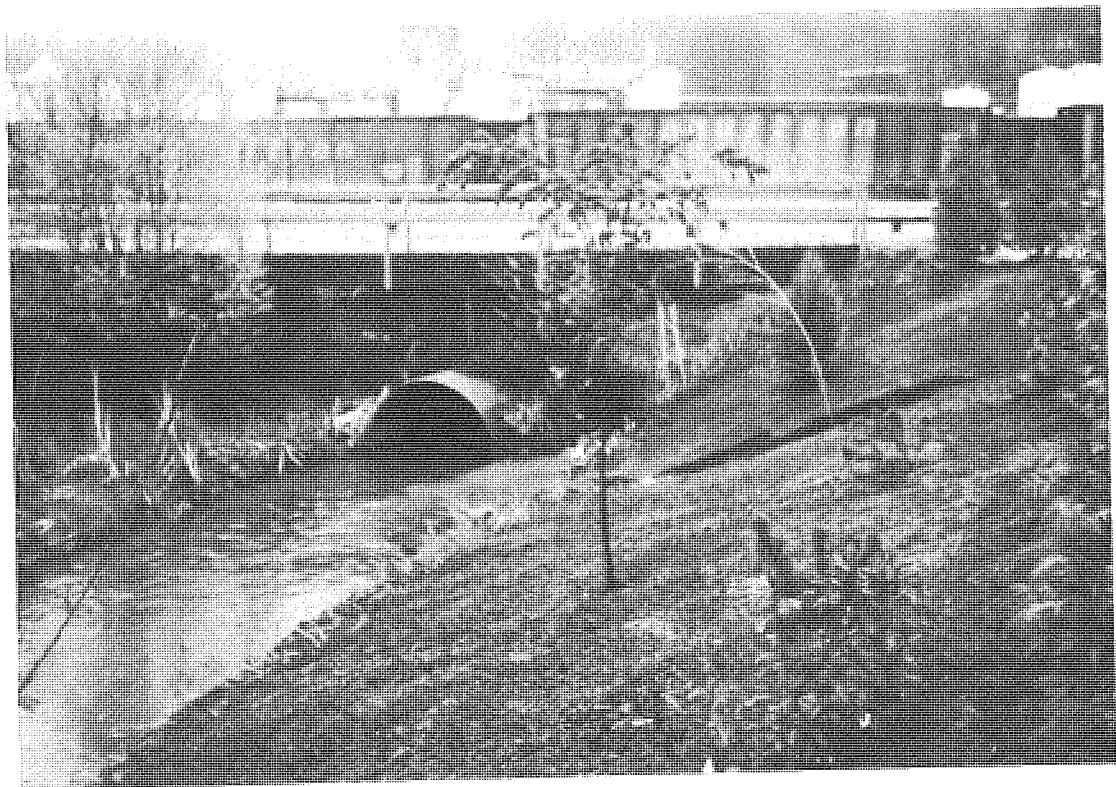
Reach S36  
CP Rail crossing looking upstream.

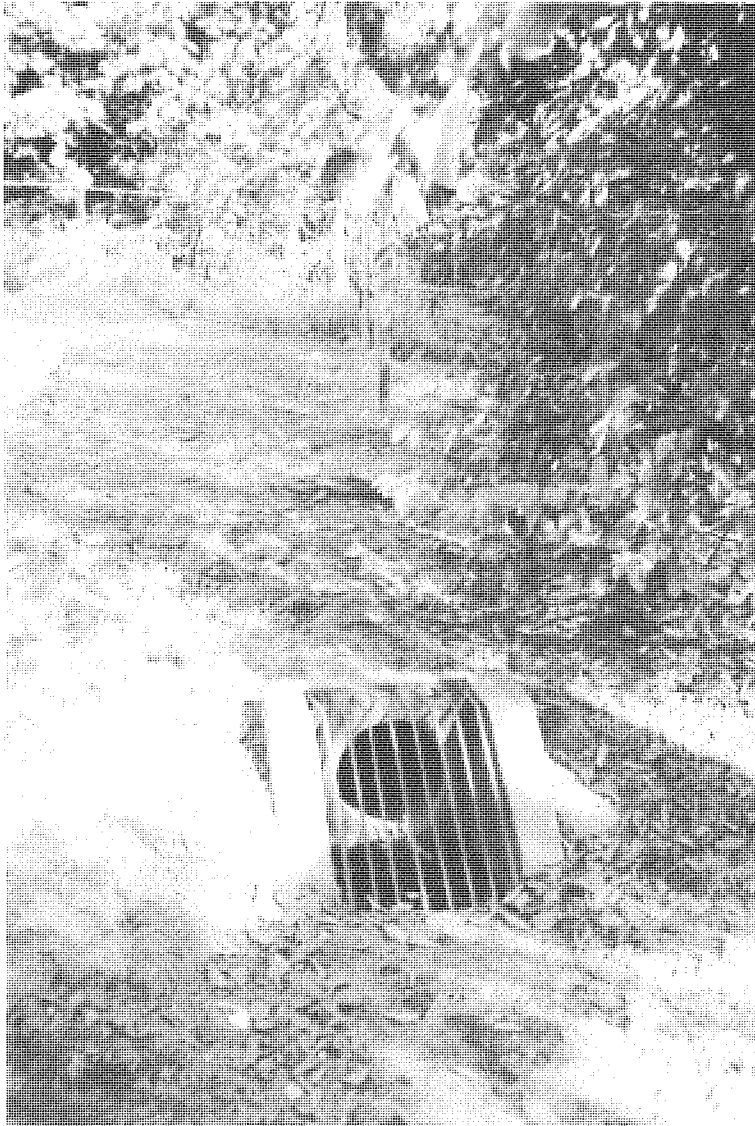
Ottley Creek ditch inlet on Porter Street, Coquitlam.

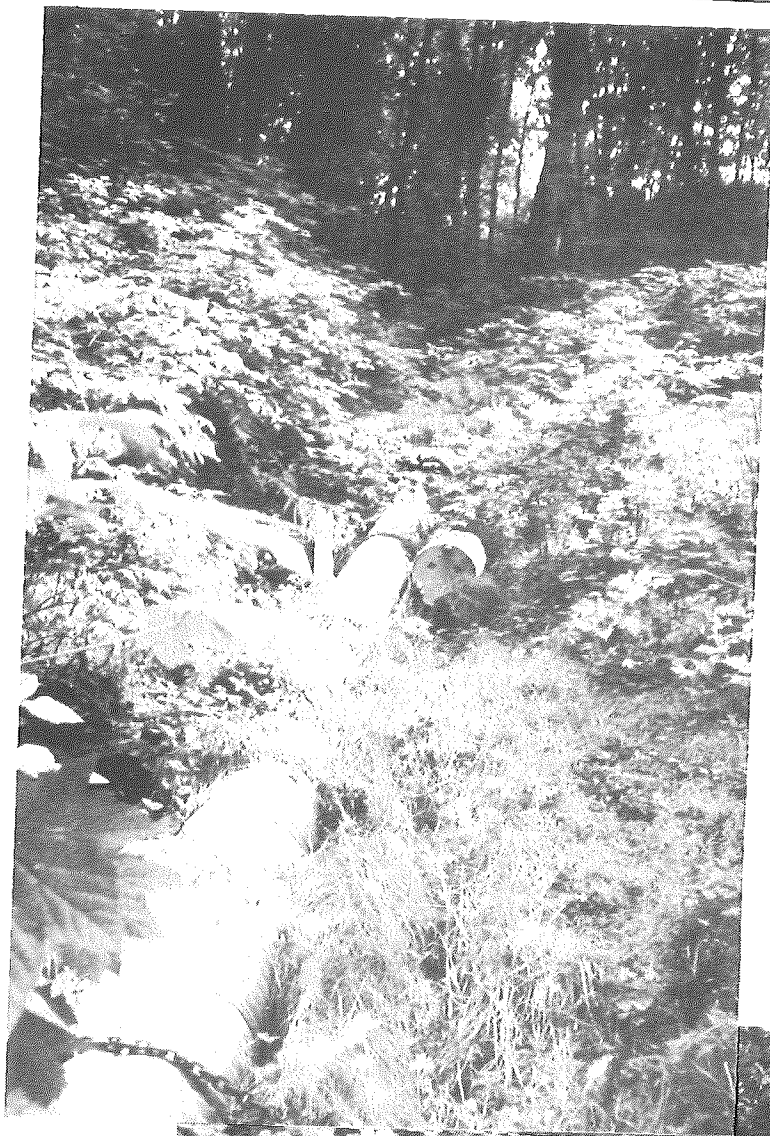
Ottley Creek drainage culvert chained  
down in flume which has undermined (in  
Schoolhouse Creek Drainage Area).

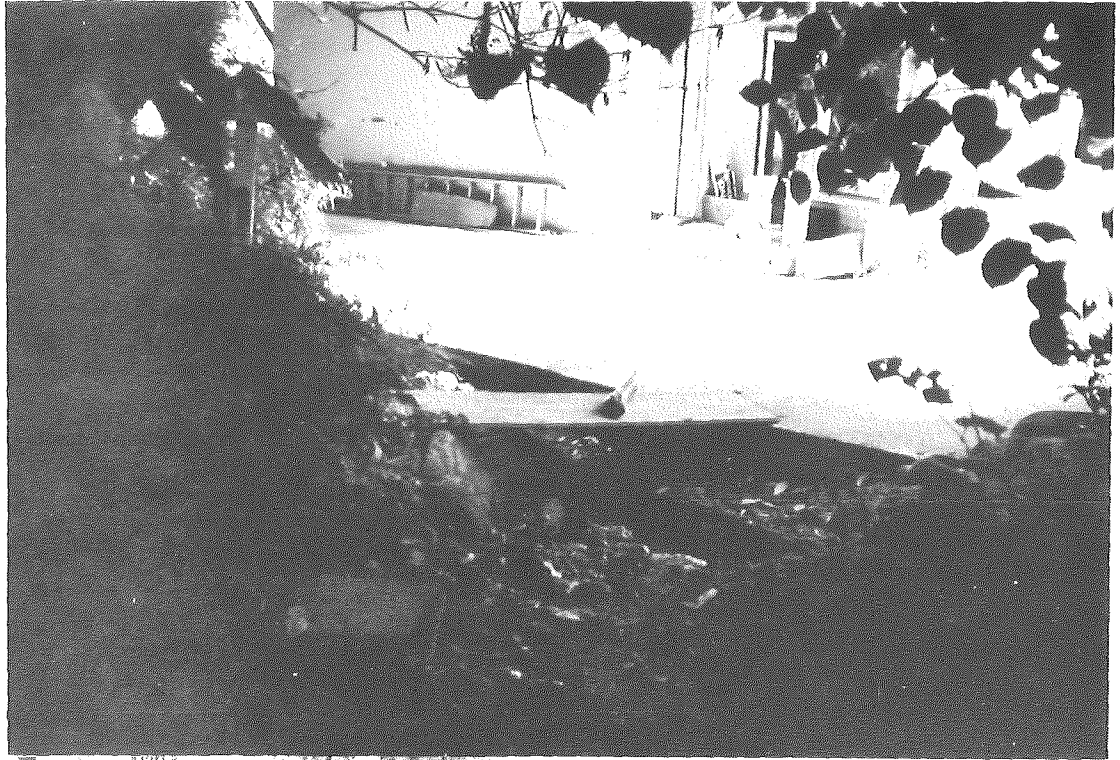
Ottley Creek ditching through private property looking downstream.

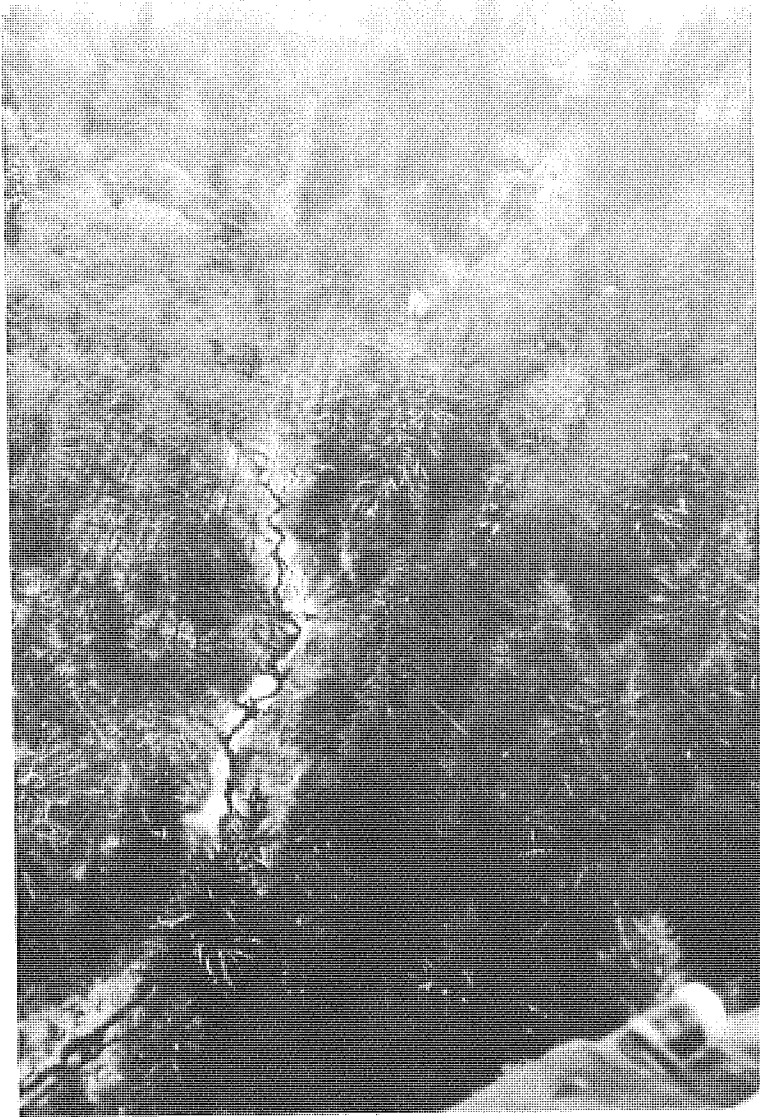
Ottley Creek head scarp showing old slide to right and new point discharge of urban drainage to left.

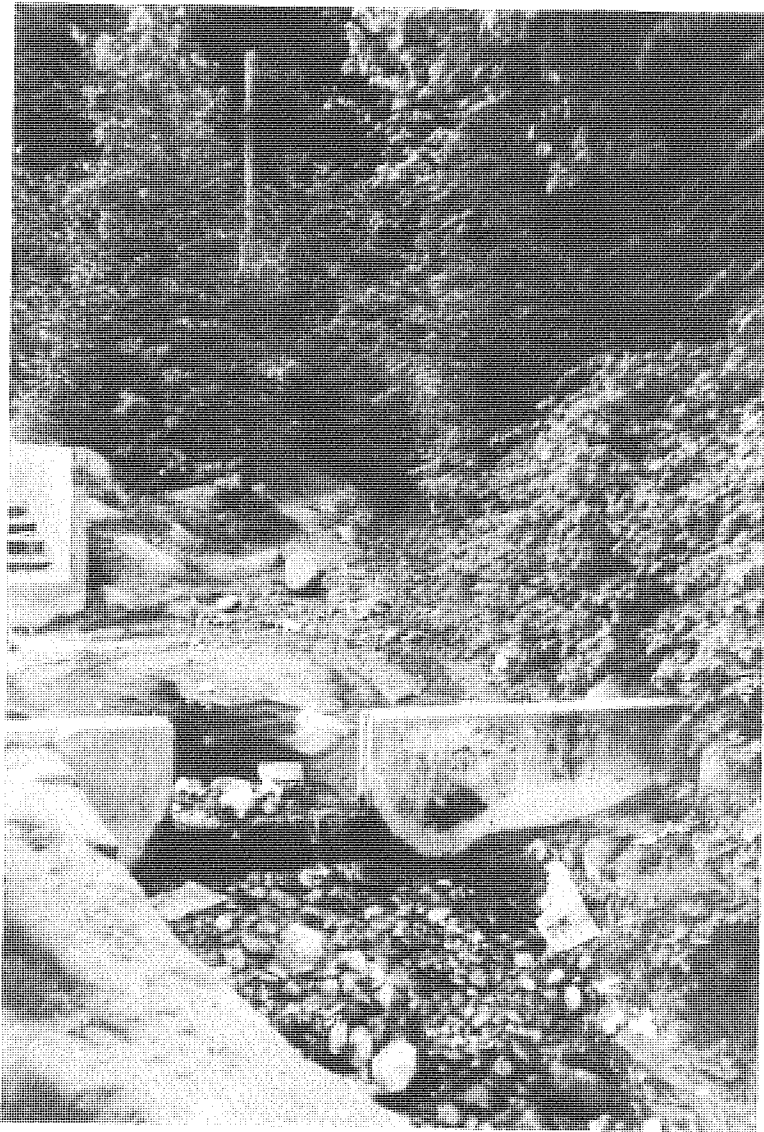
Reach K10

Kyle Creek channel,  
sediment trap and intake at  
George Street and Kyle  
Street, in Kyle Street  
Drainage Area.

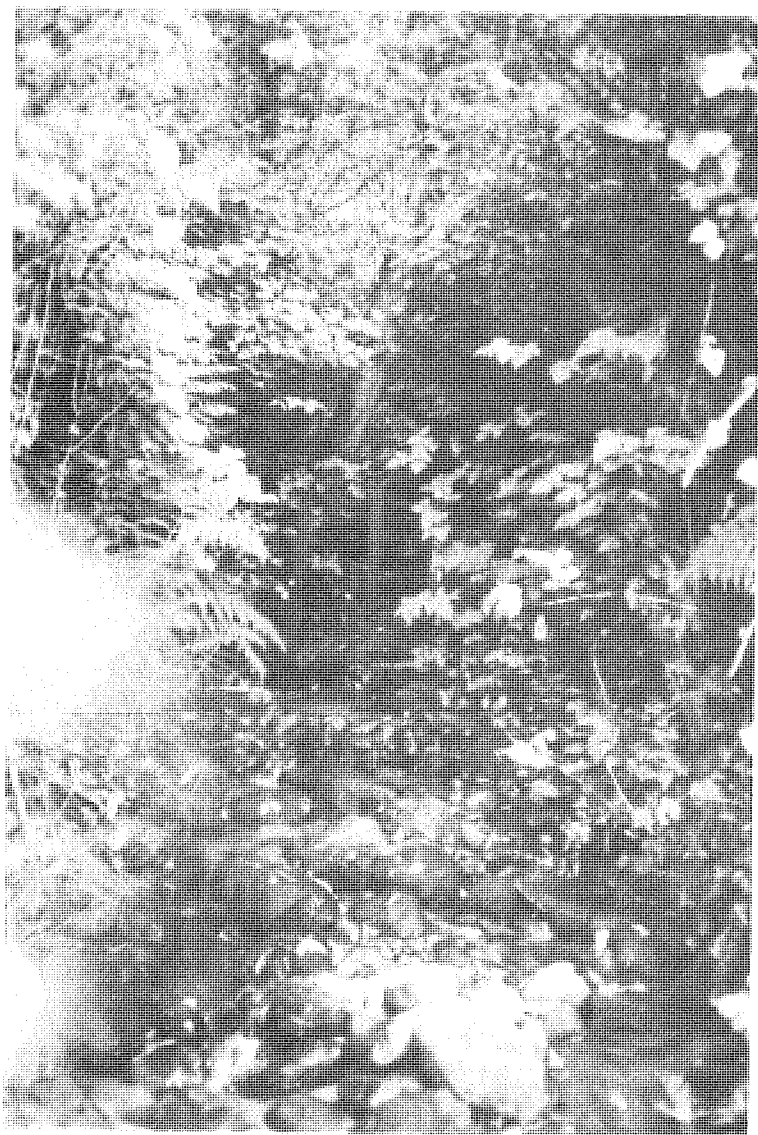
Reach K16

Hachley Creek channel and inlet at Jane Street east of Grant Street. (Note trash guard pickets) in Kyle Creek Drainage area.

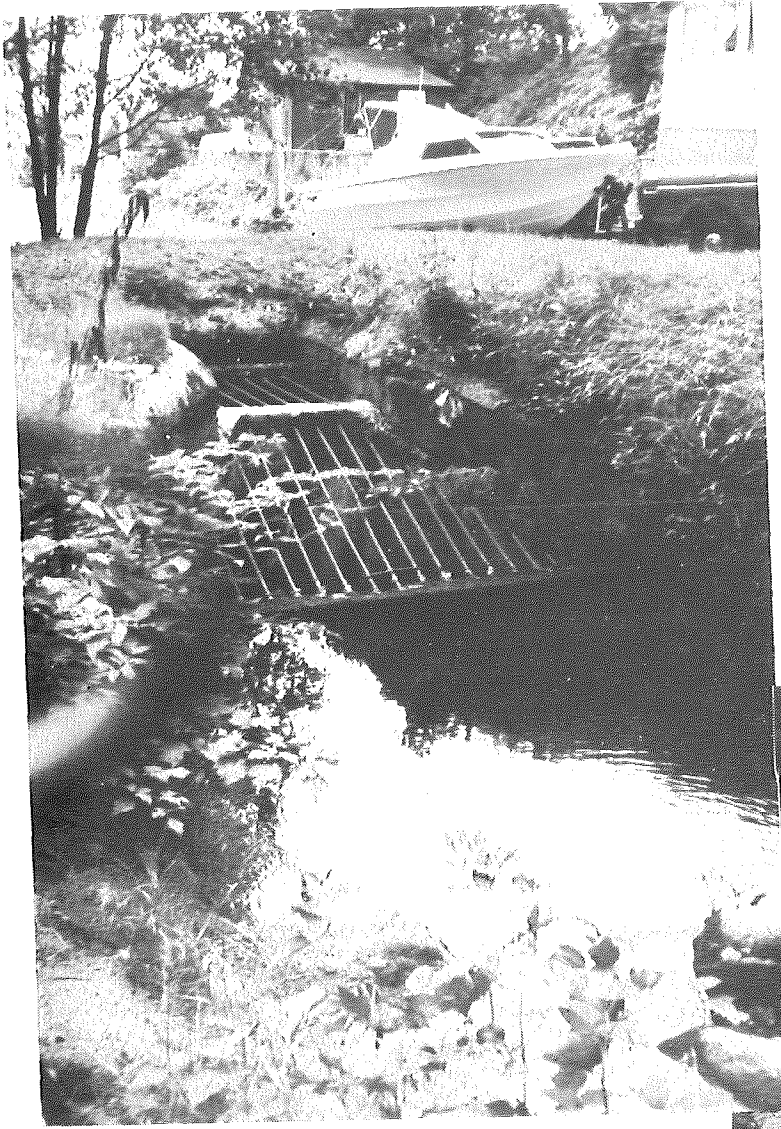
Sundial Creek channel, sediment traps, trash guard pickets and intake in Kyle Creek Drainage Area.

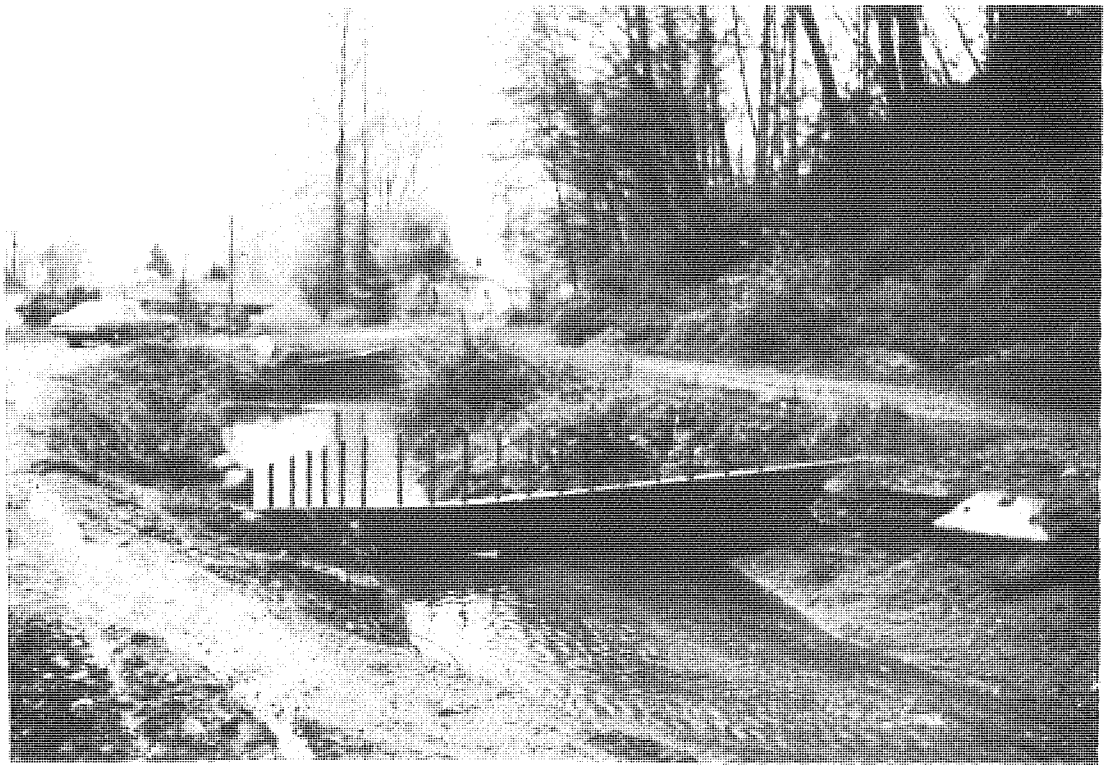
Goulet Creek sediment basins cleaned.

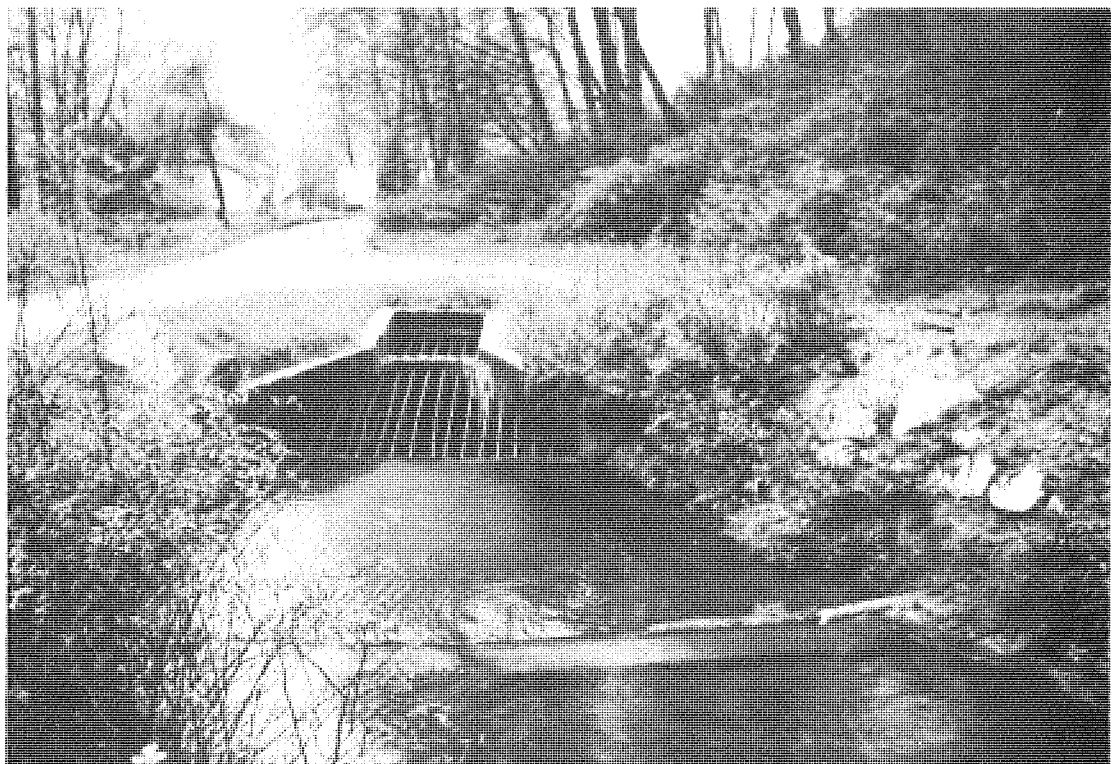
Goulet Creek inlet cleaned.

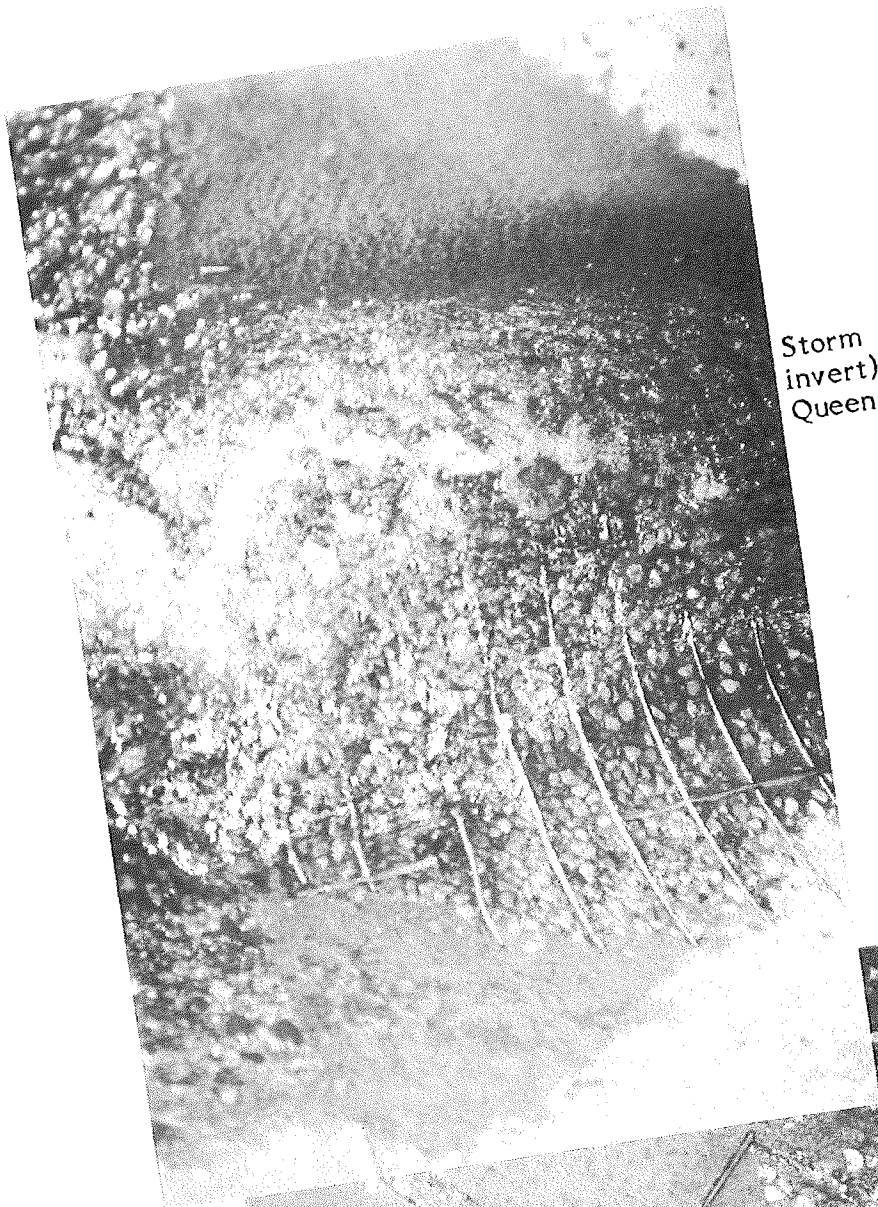
Storm drain (built 1962, 50% loss of invert) from Hugh to the bottom of Queens.

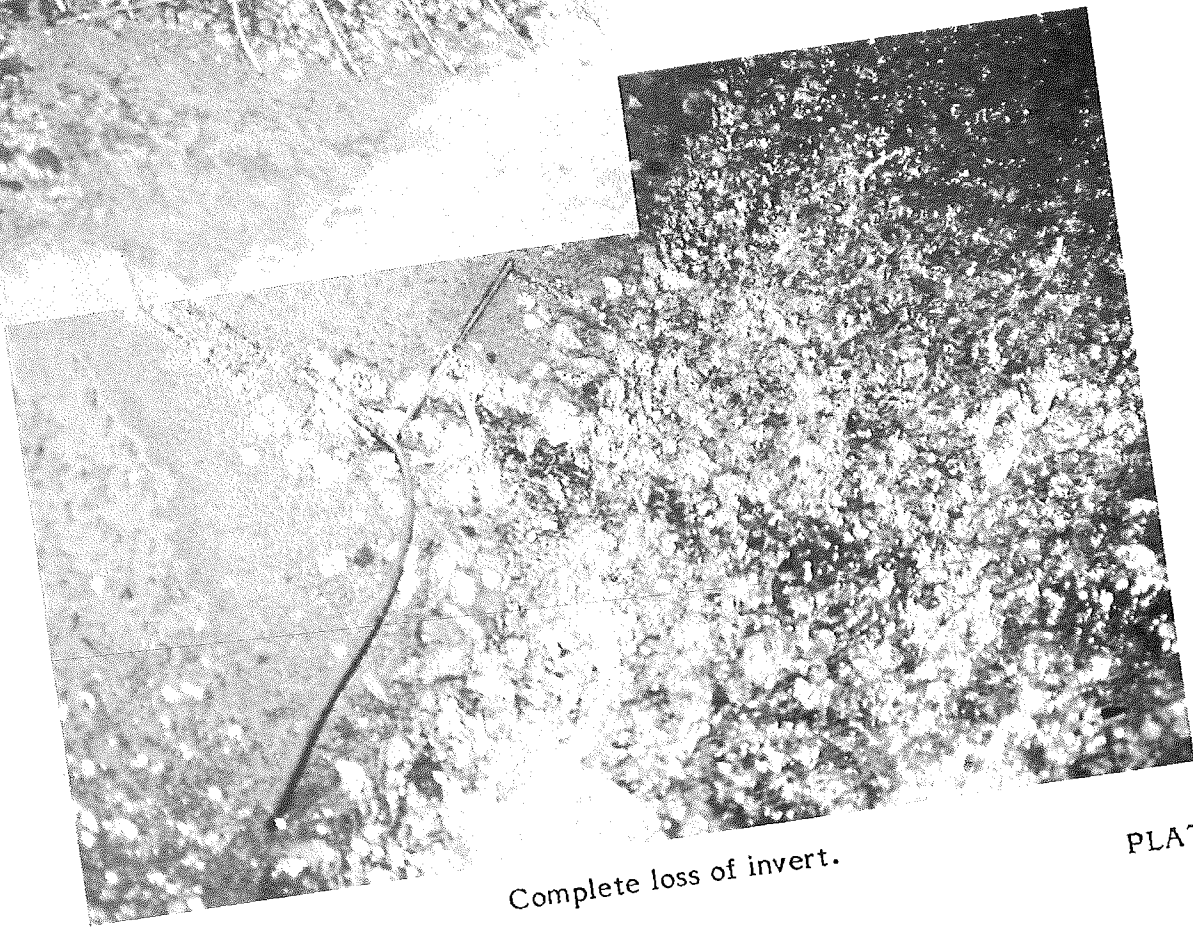
Complete loss of invert.

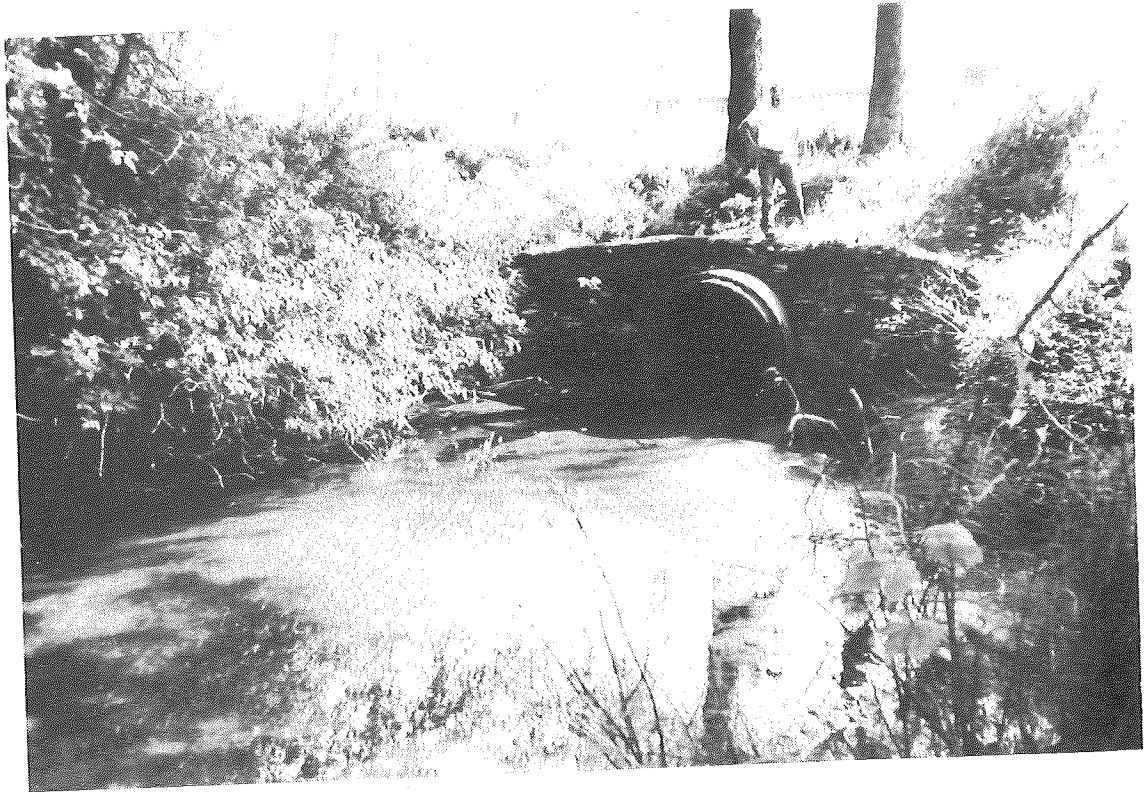
Kyle Creek - 1,800 $\phi$  (60 inches) outfall.  
September 9, 1987.

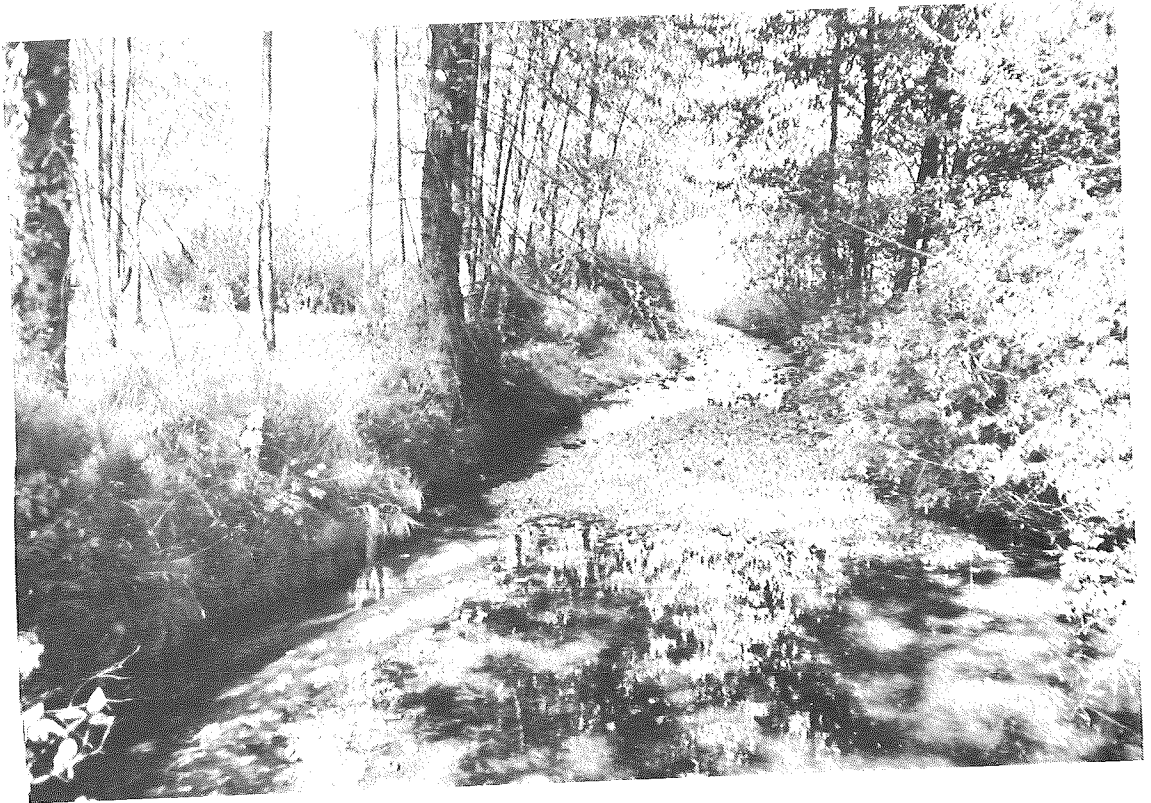
Gravel bar at discharge.

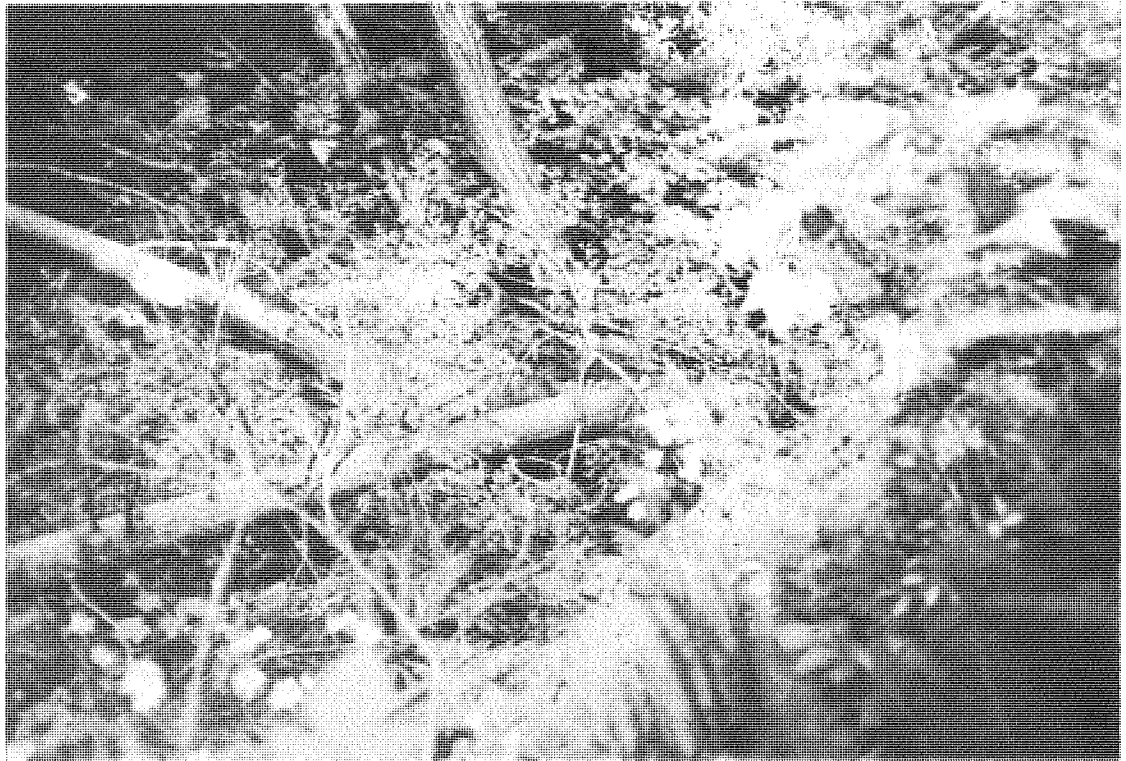
Windfall in Elgin House Drainage Basin caused by undermining of headscarp.
