ENGINEERING DEPT.  
**GREATER VANCOUVER  
SEWERAGE AND DRAINAGE DISTRICT**

**STUDY OF**

**COQUITLAM / PORT MOODY  
DRAINAGE AREA**

**DAYTON & KNIGHT LTD.**  
*Consulting Engineers*

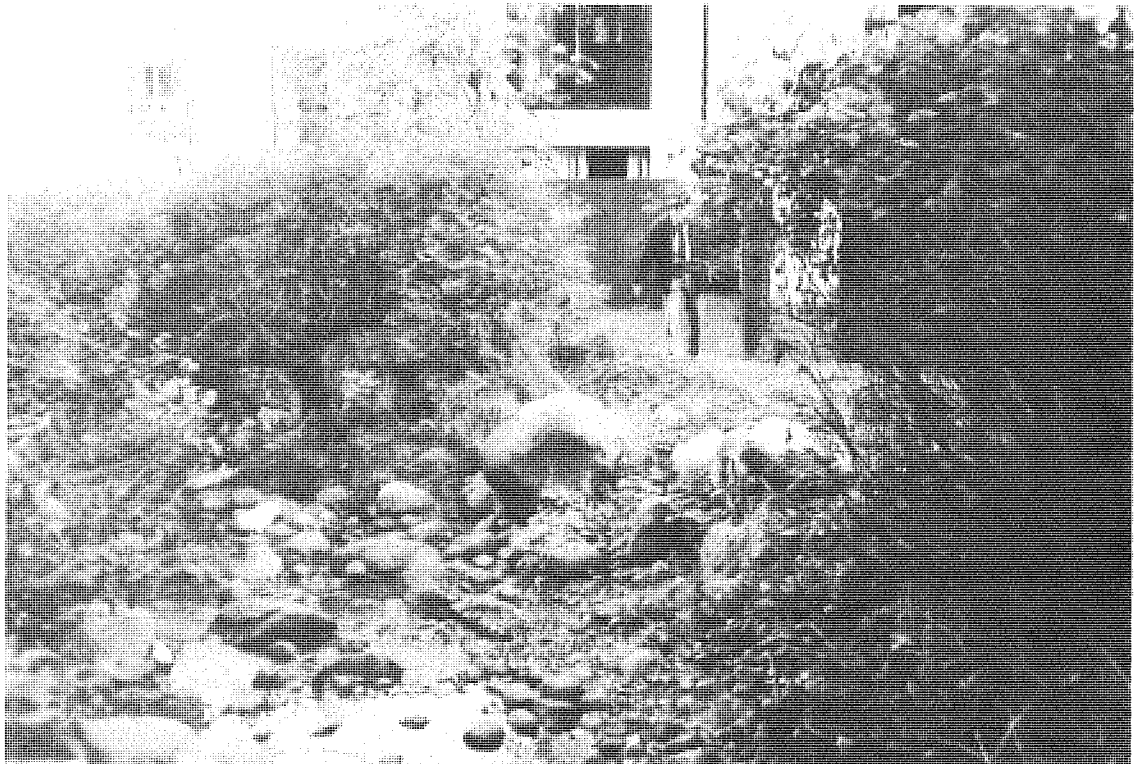
Reach W12  
Dallas Creek at apartments above Elgin House Creek confluence.  
Note low bankfill flow capacity.

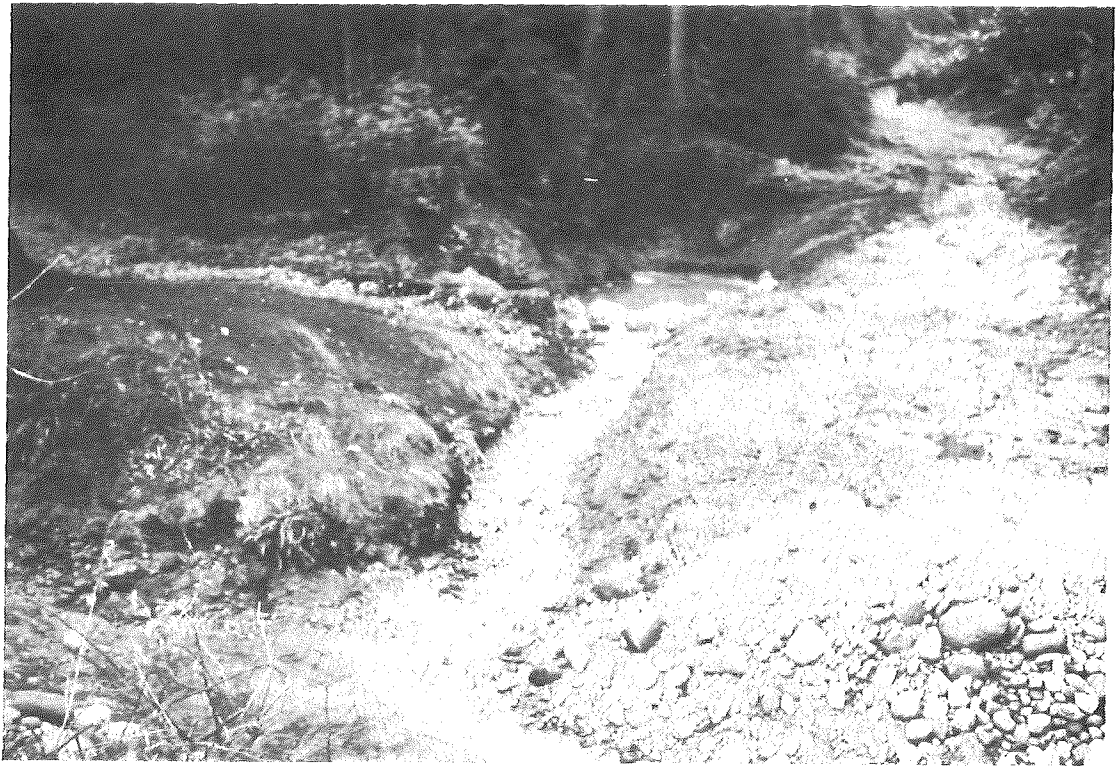
Elgin House Creek confluence at Dallas Creek

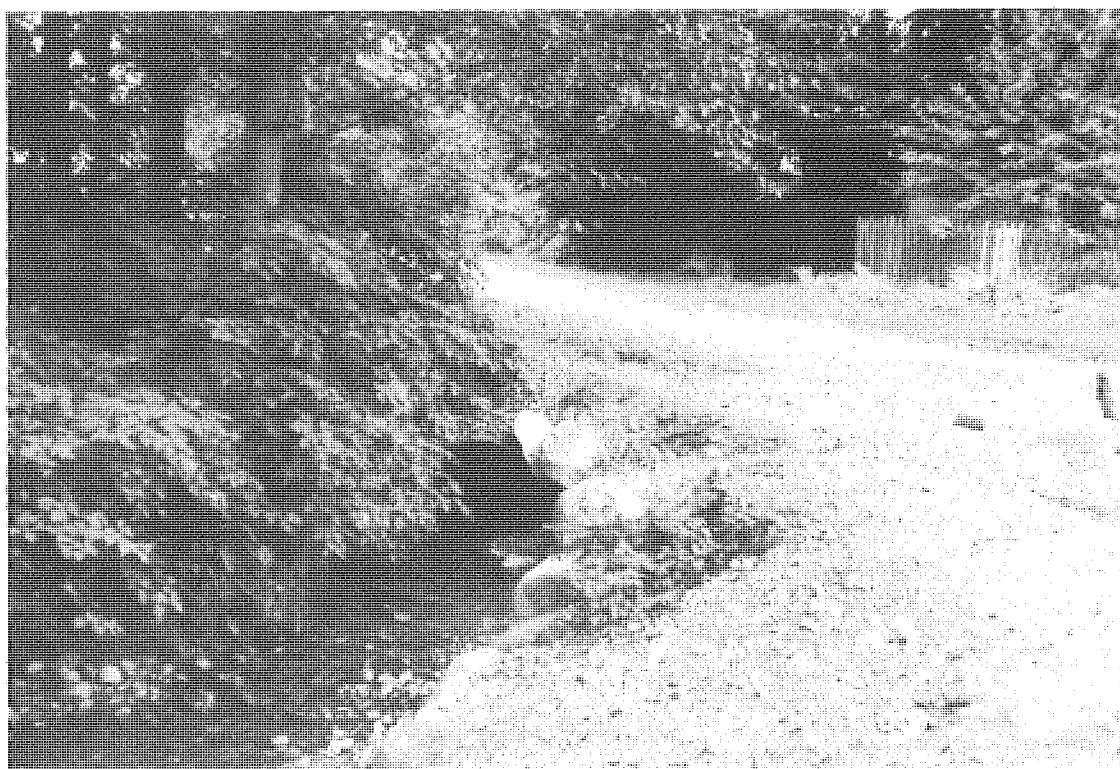
Reach W13

Elgin House Creek, Correl Brook and Dallas Creek (Slaughterhouse Creek)  
downstream of confluence, Hope Street alignment crossing in Williams Creek Drainage Area

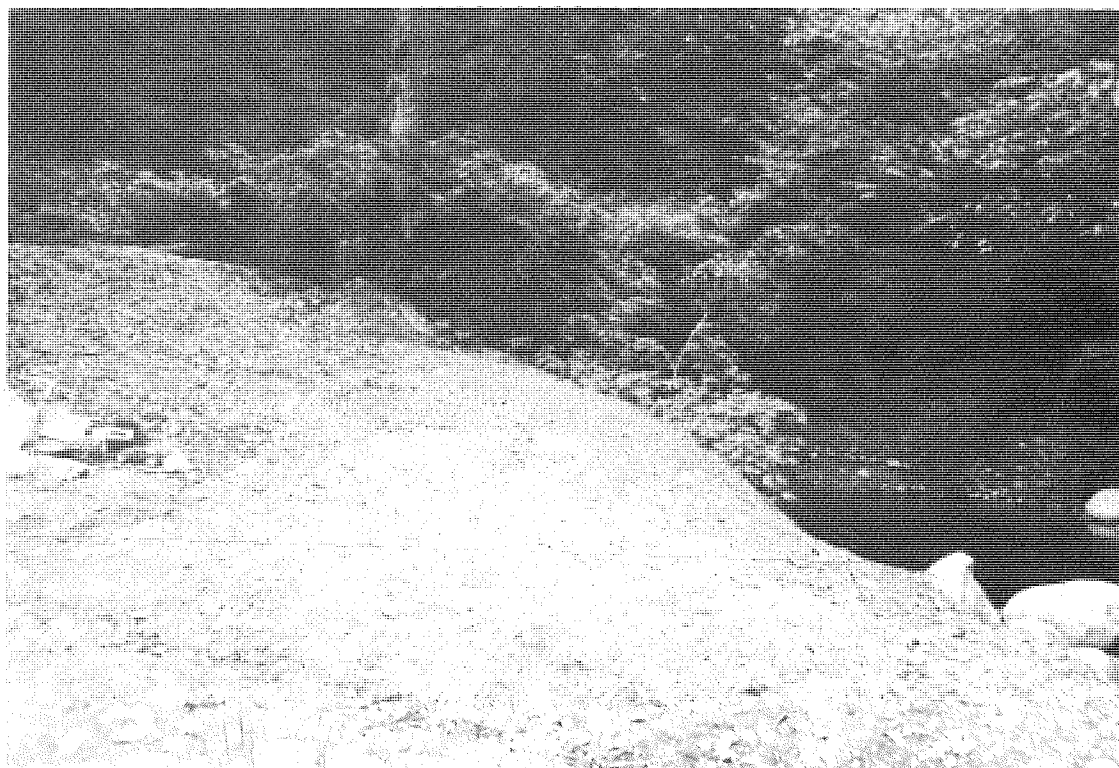
Sediment Pond at Elgin House Creek confluence - September 3, 1987

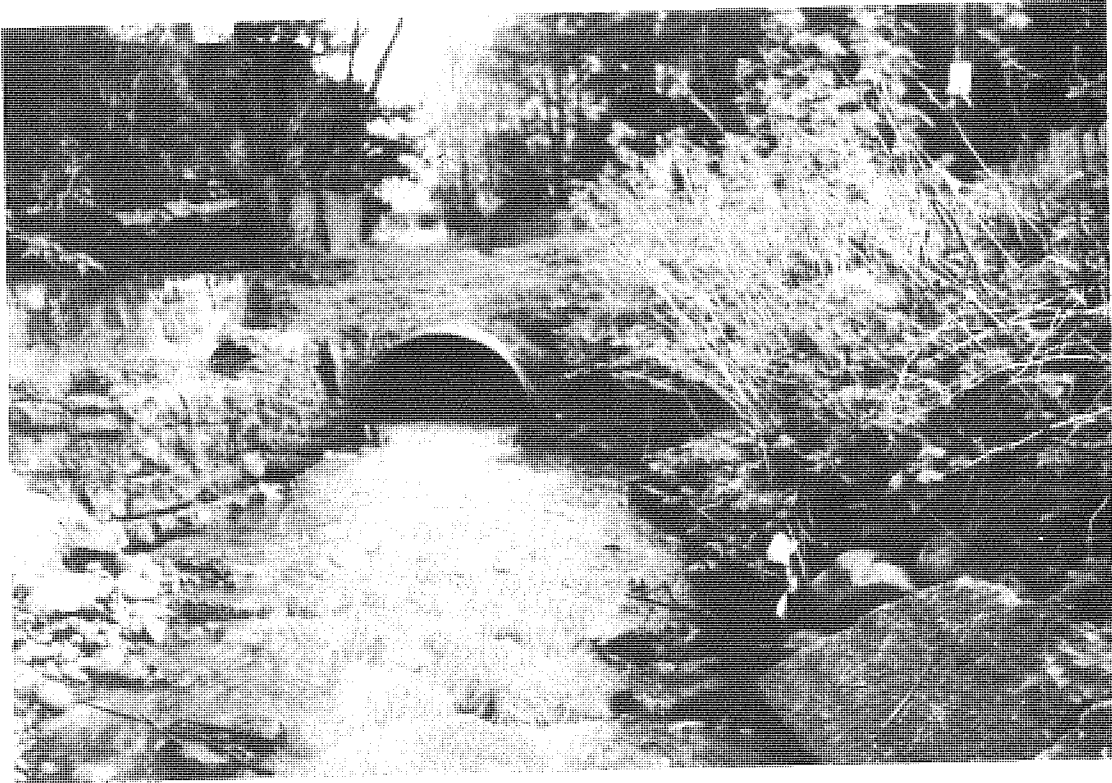
Reach W14  
Dallas Creek discharge looking upstream at Hope Street

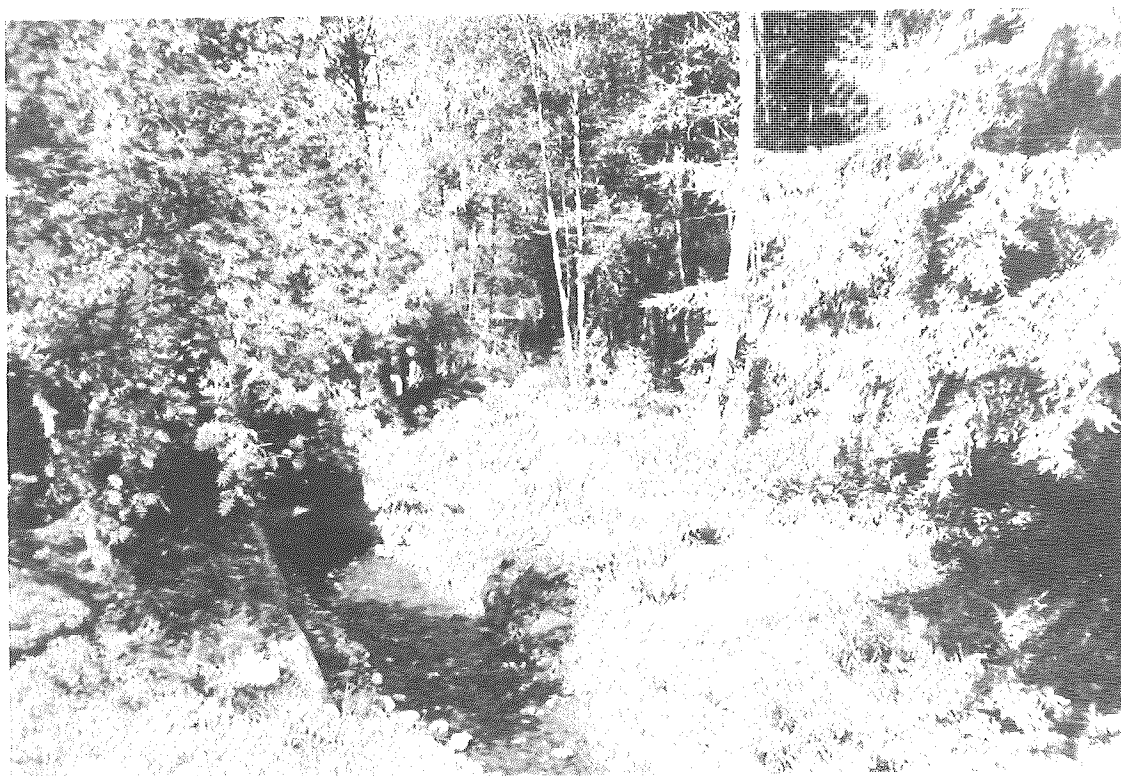
Dallas Creek looking downstream from St. Georges Street flood plain to right.  
Floods in high flows (confluence of Williams Creek and Dallas Creek  
in background not visible).

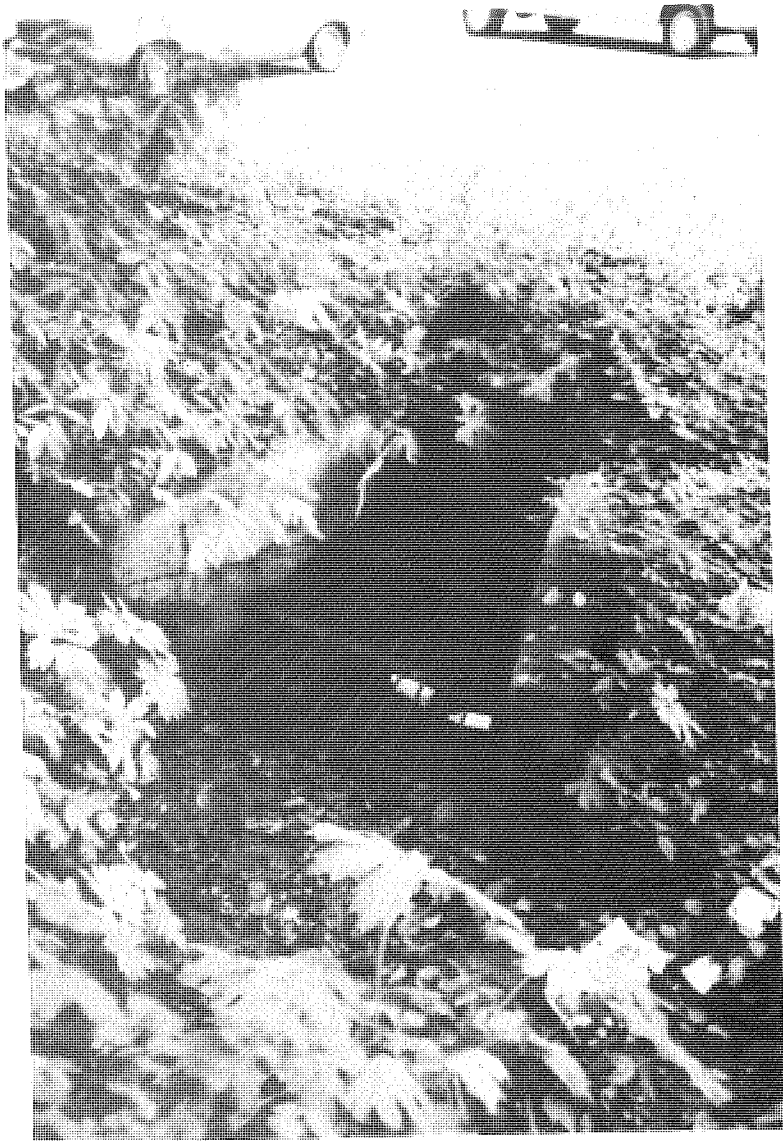
Reach W7

Williams Creek intake and channel at  
Henry Street above apartments in  
Williams Creek Drainage Area.

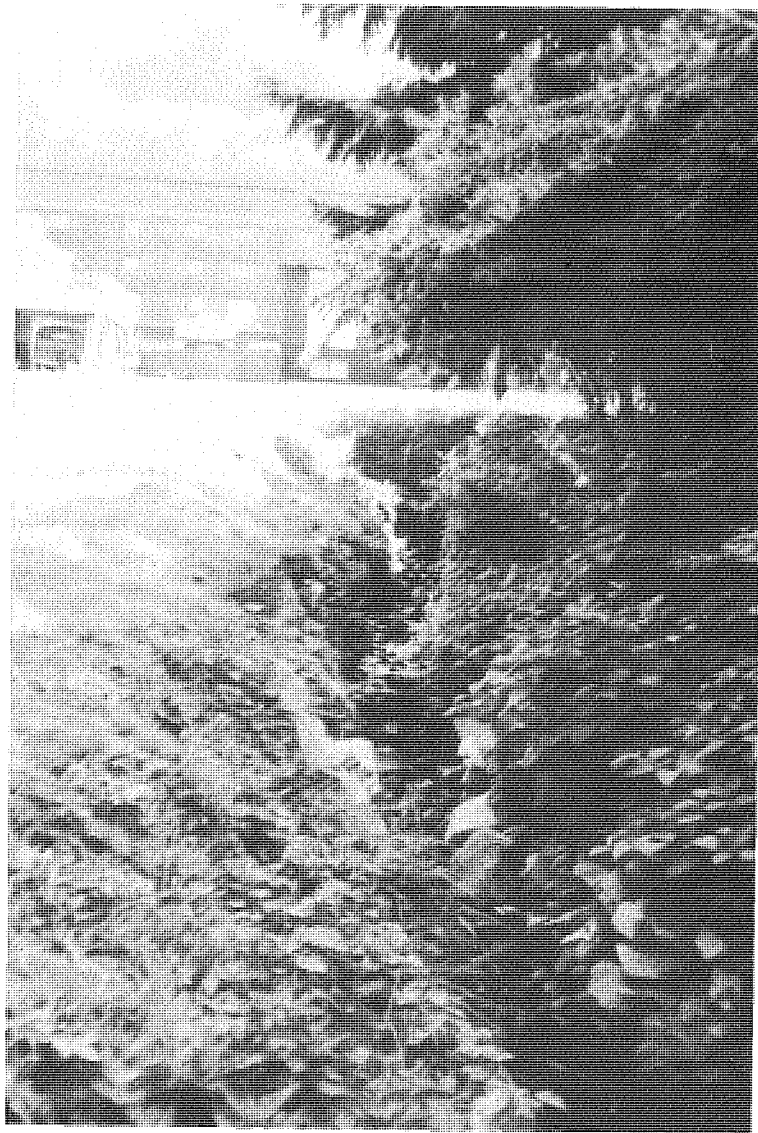
Reach W9

Hand placed rock lined channel from Williams Creek looking upstream across St. George Street. Storm drain is sediment filled in upstream reaches and lower section is tapered,

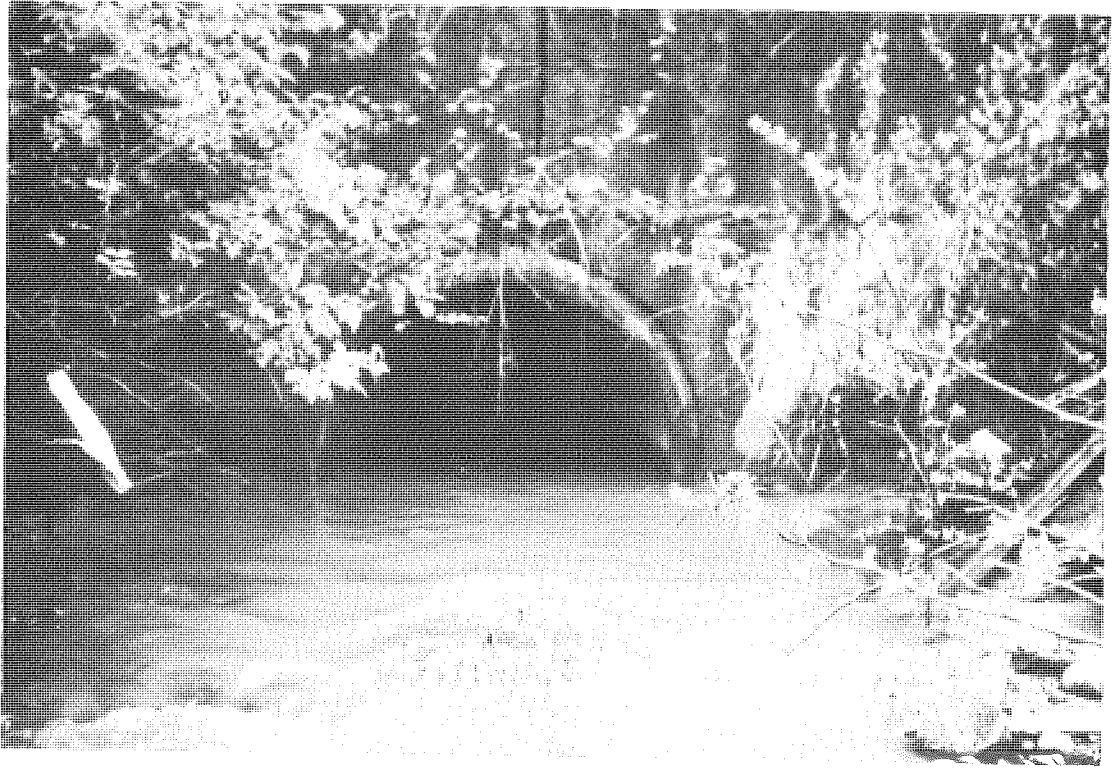
Reach W20  
Under warehouse just above C.P. Rail
