ENGINEERING DEPT.  
**GREATER VANCOUVER  
SEWERAGE AND DRAINAGE DISTRICT**

**STUDY OF**

**COQUITLAM / PORT MOODY  
DRAINAGE AREA**

**DAYTON & KNIGHT LTD.**  
*Consulting Engineers*

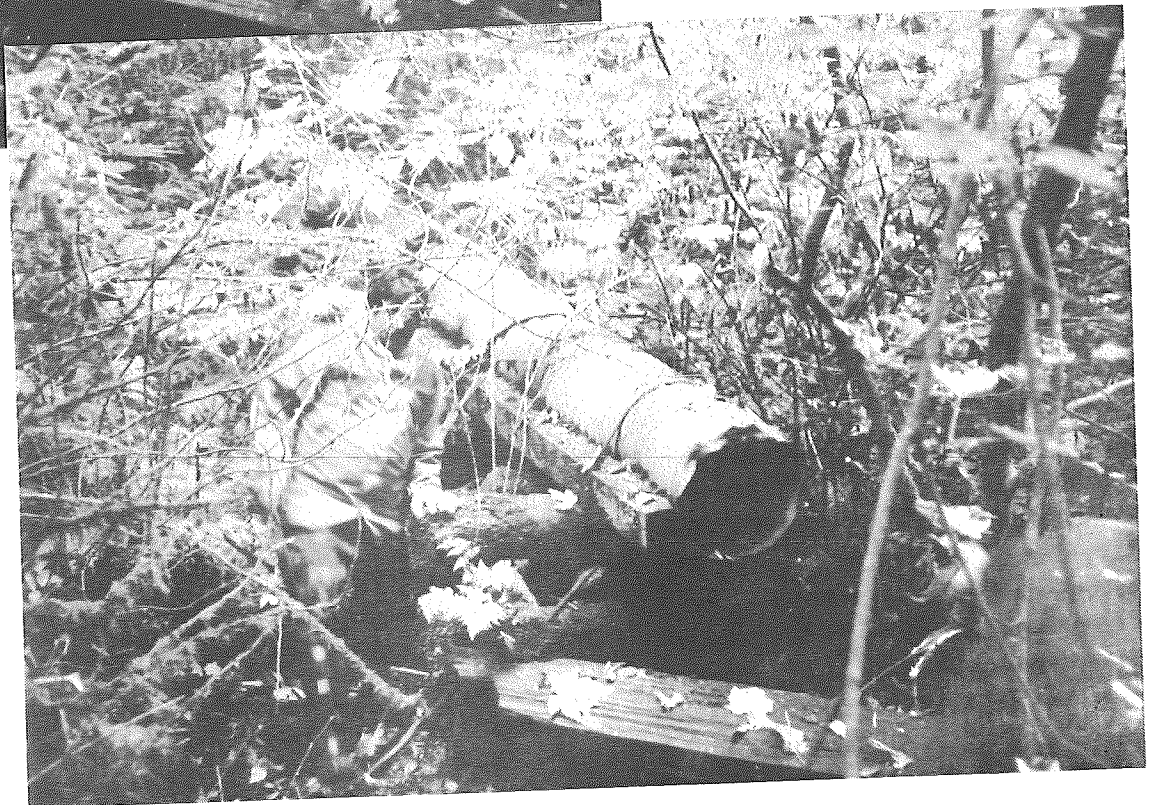
Reach S4.

Ingersol Avenue Outfall

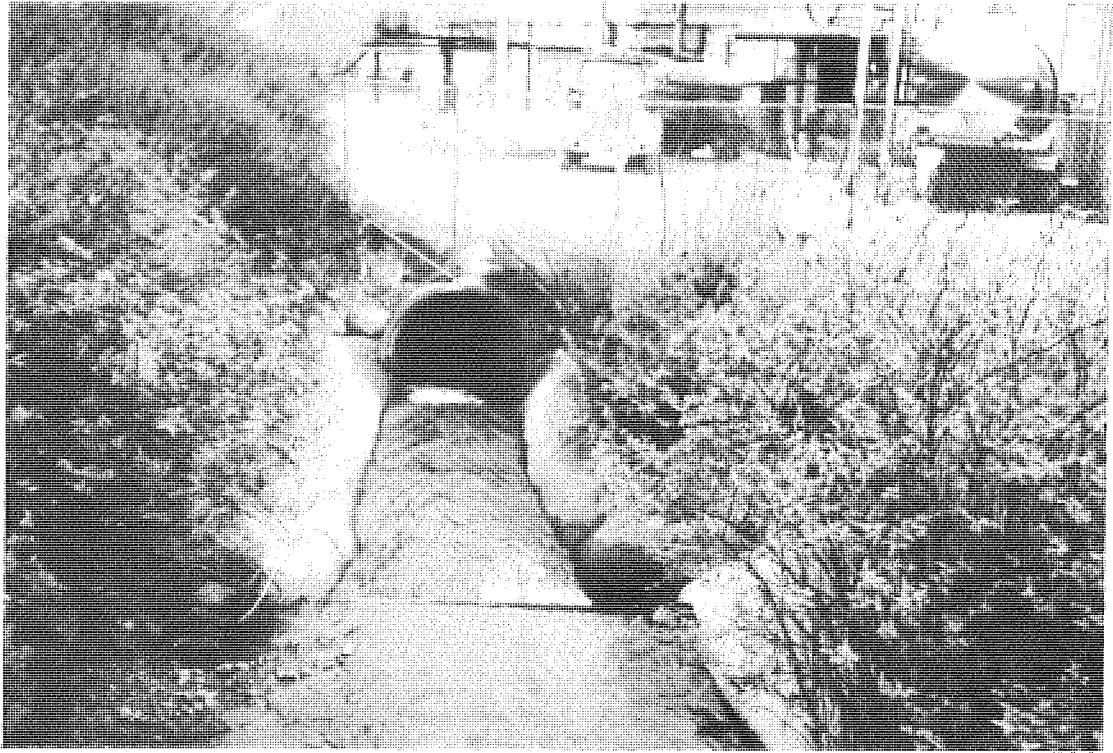
Reach S30/S35  
Through Riechhold Chemicals looking downstream.

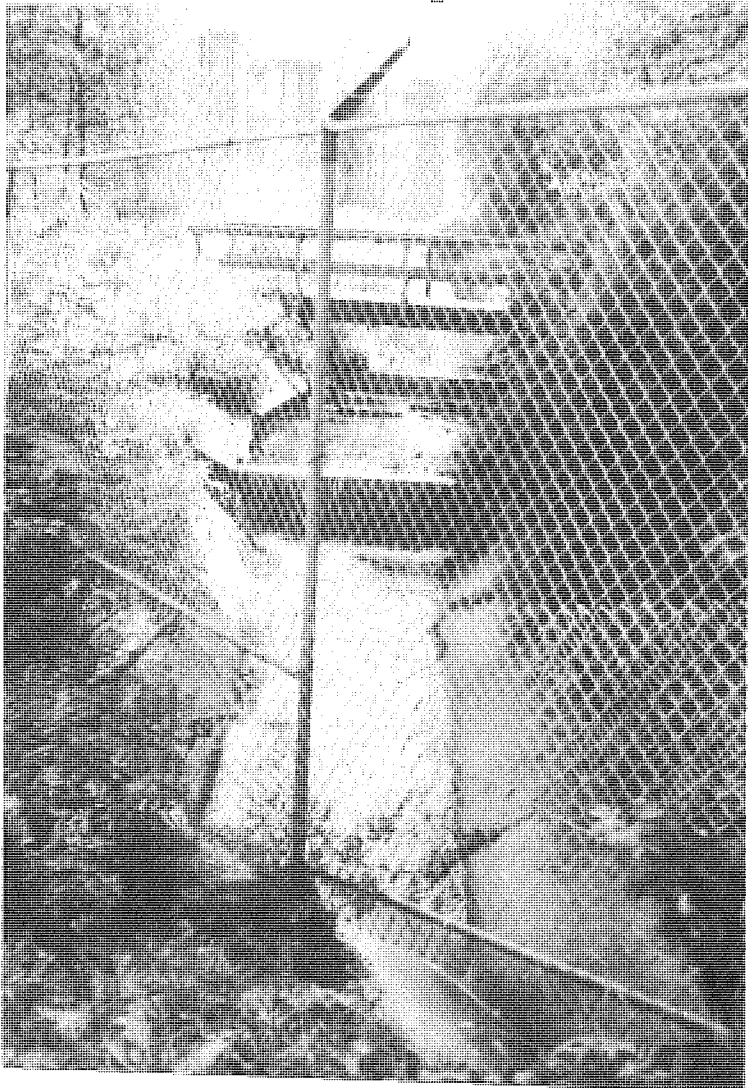
Reach S30  
Looking upstream to Andres Wines.

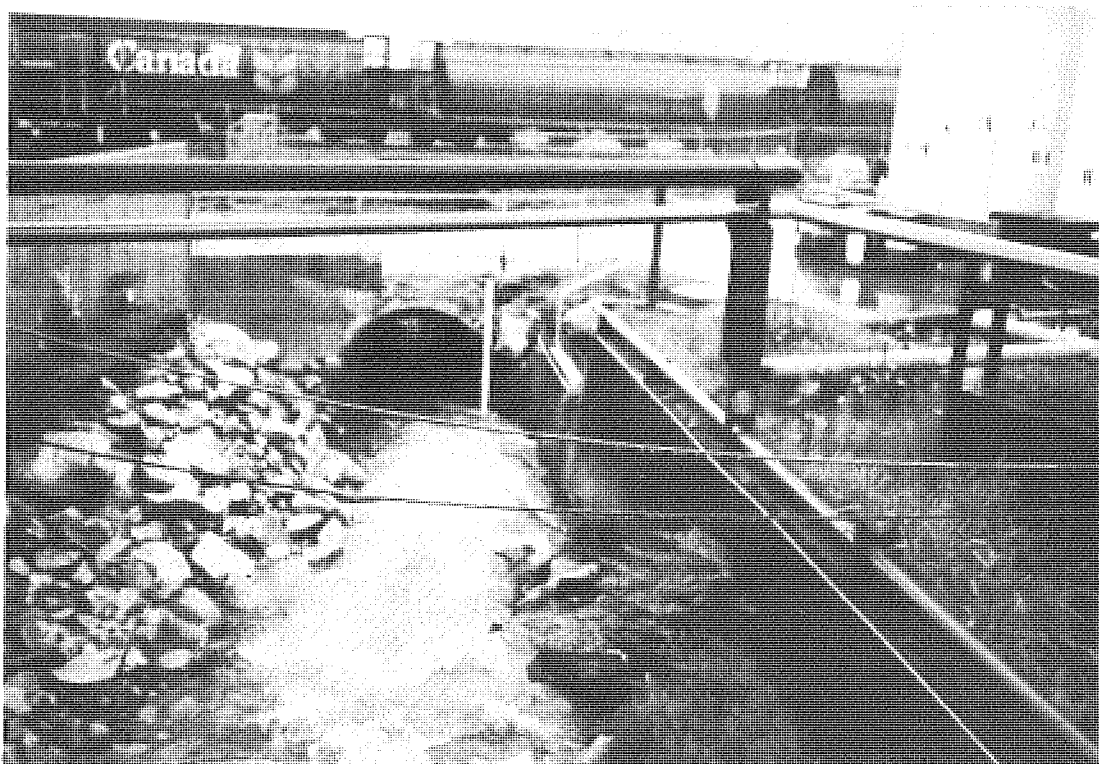
Reach S35  
Through Riechhold Chemicals looking downstream.  
CP Rail in background.

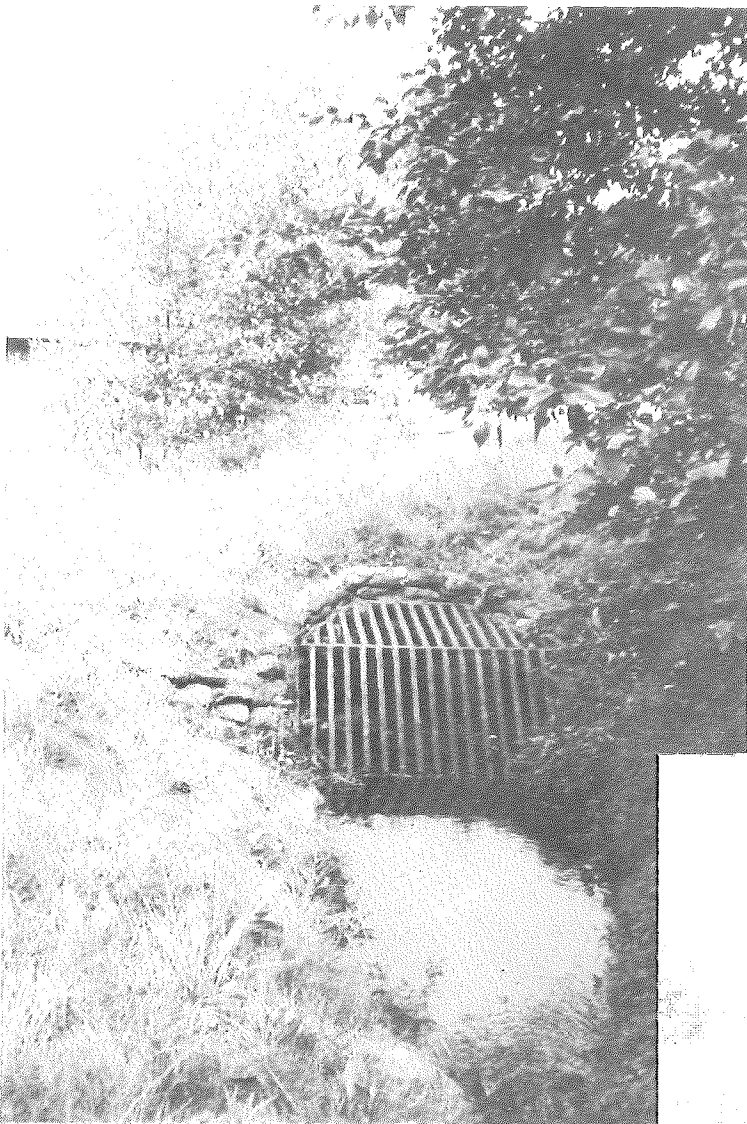
Ottley Creek inlet and settling ponds (2)  
in Schoolhouse Creek Drainage Area.

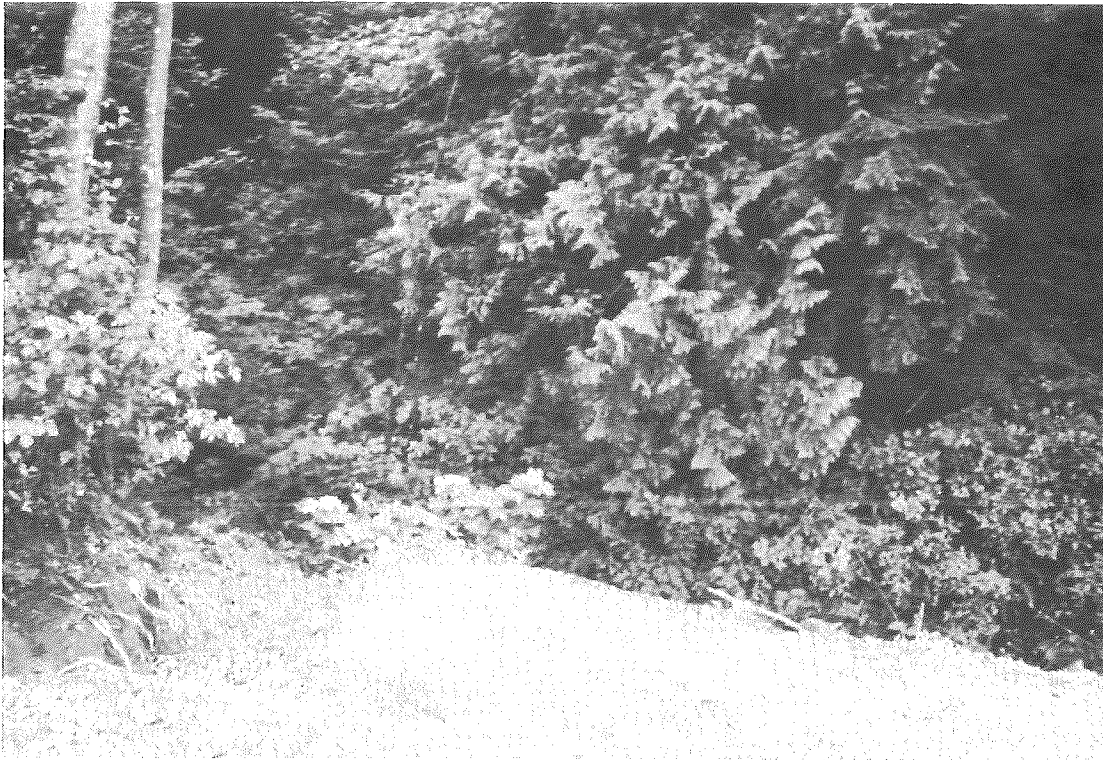
Reach K2

Axford channel looking over road shoulder at Henry Street and Elgin Street.

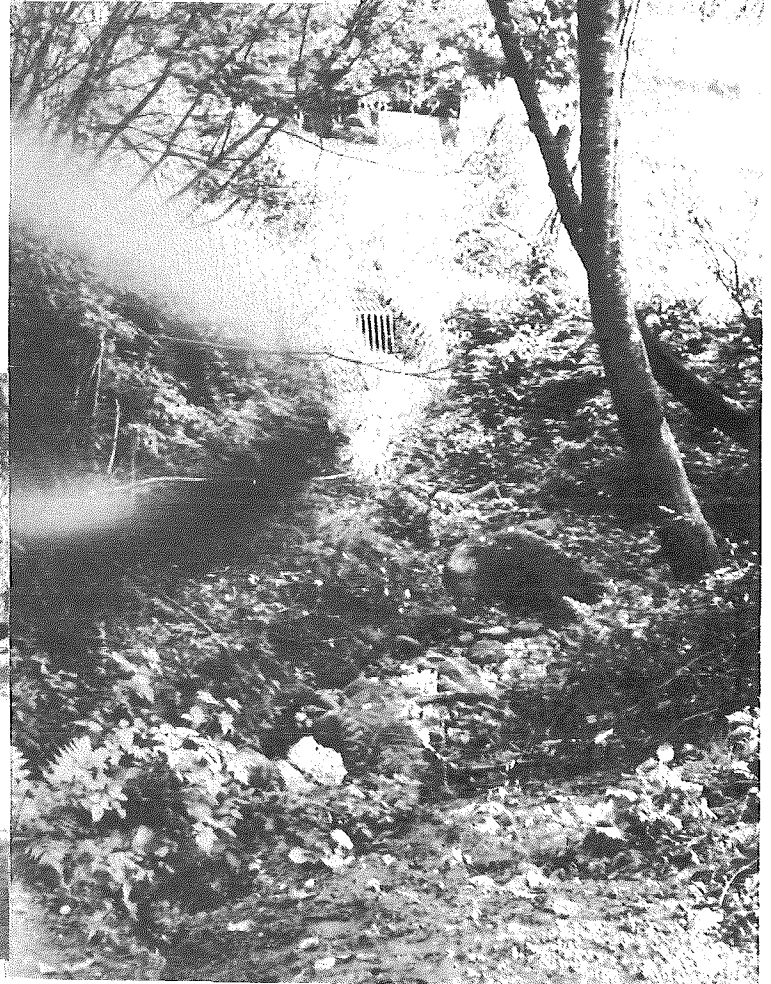
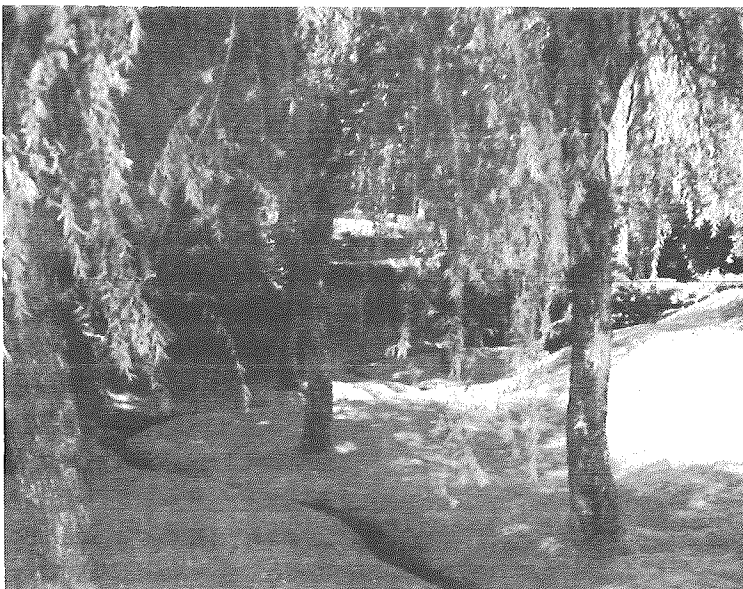
Reach K3

Axford channel looking upstream from St. George Street.

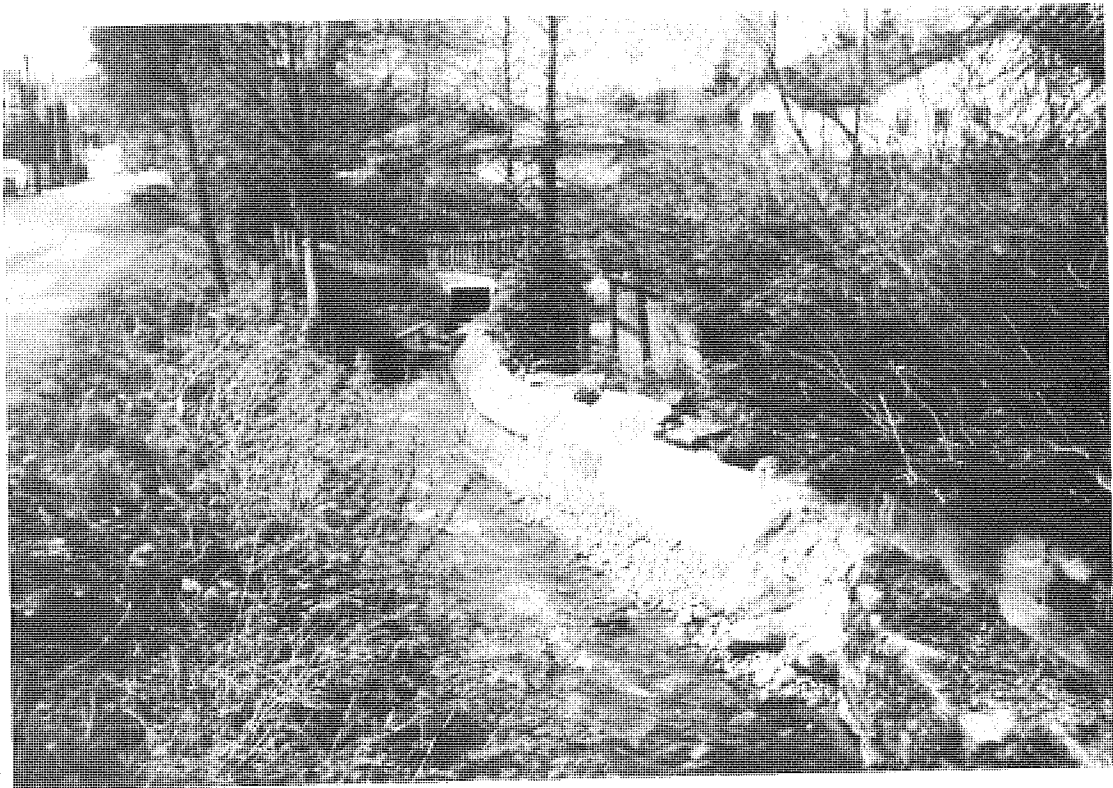
Reach W15  
Looking downstream at Hope Street

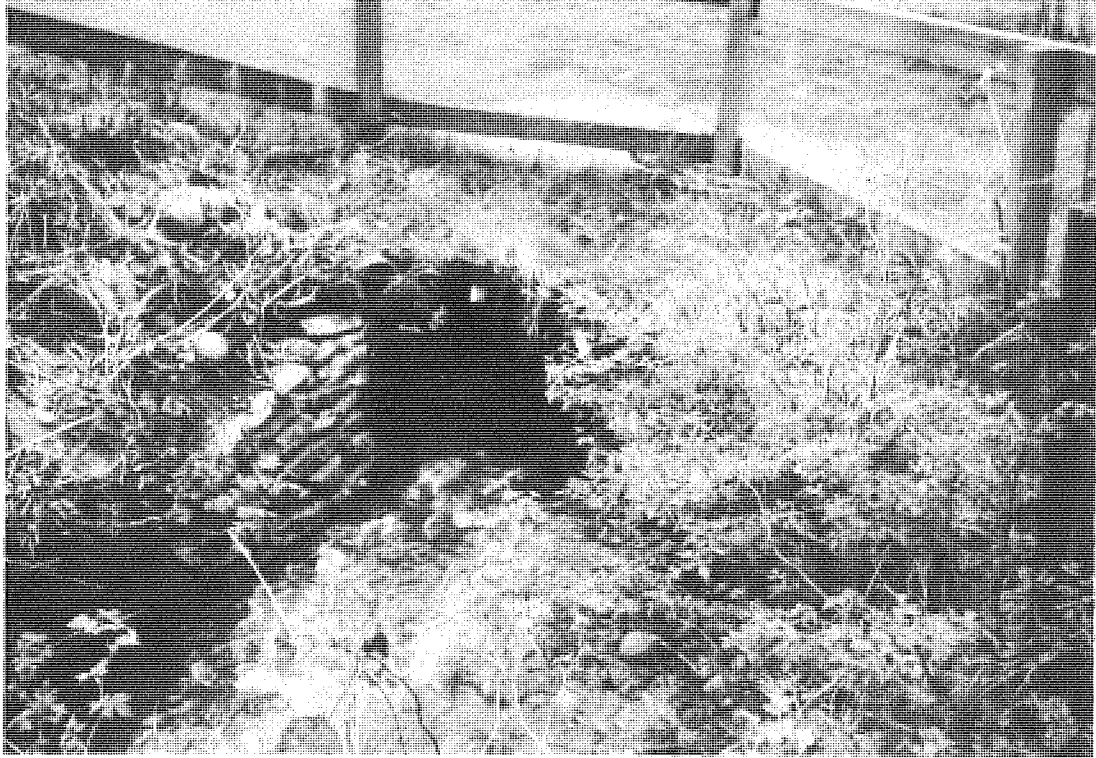
Reach W16  
Dallas Creek at St. George Street inlet looking  
downstream across St. George Street

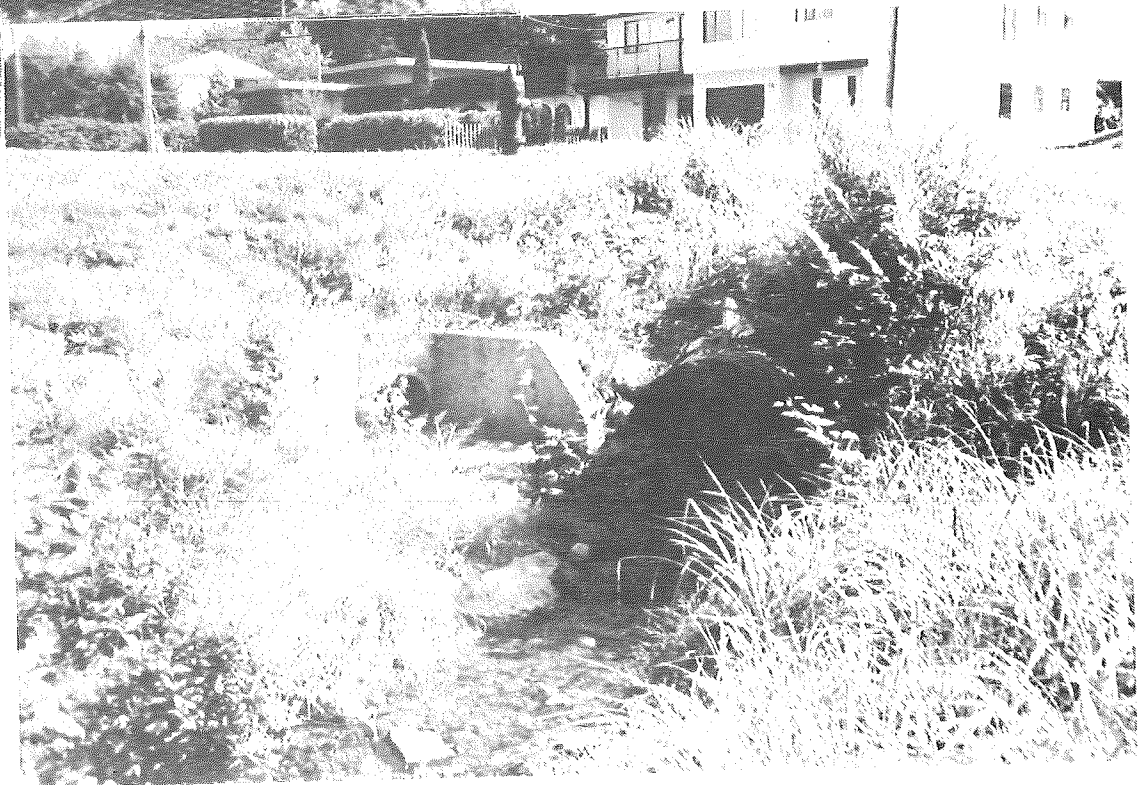
Looking upstream across St. Georges Street

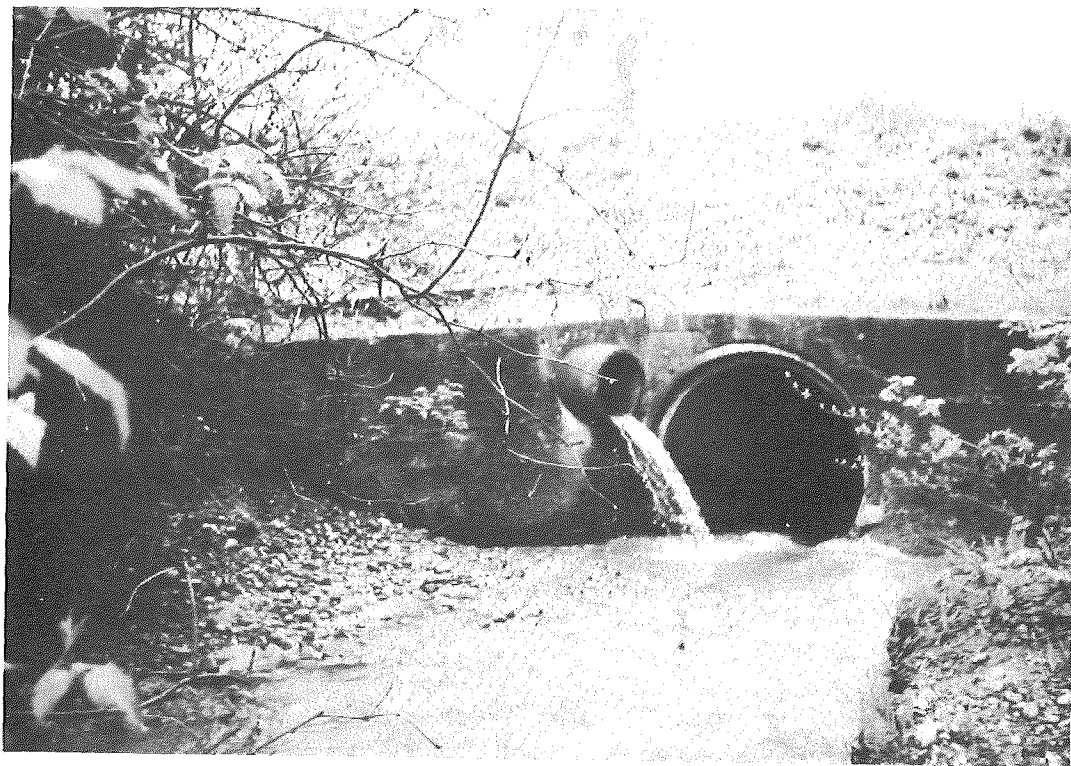
Reach W19

St. John Street Crossing below Williams Creek and  
Dallas Creek confluence.
